Use of Geosynthetics in Remediation of Bauxite Residue Disposal Area

Bill Smith, P.E.¹, Ron Morosky², John Gardner, P.E.³

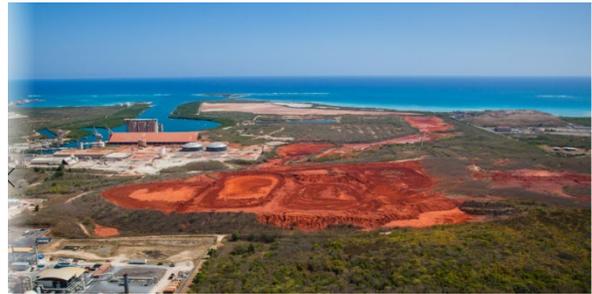
In this highly visible environmental application, geosynthetics were used to achieve dust control, soil reinforcement and erosion protection in the remediation of a former 75 acres (30.3 ha) bauxite residue disposal area located on the island of St. Croix, US Virgin Islands. In 2002, dike failures led to the uncontrolled releases of bauxite residue into a cooling pond, settling basin, and surrounding area (see Photo 1).

Photo 1. BRDA Site Before Remediation

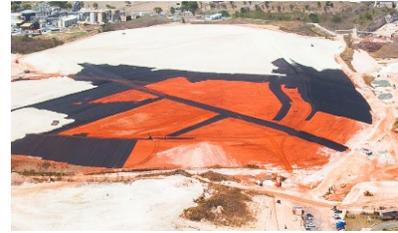
Photo 2. Dust Control

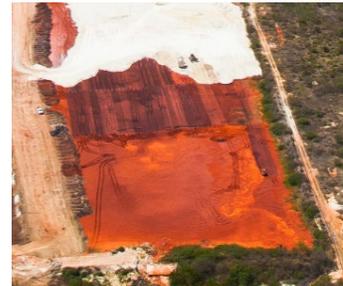
Photo 3. Geogrid Placement

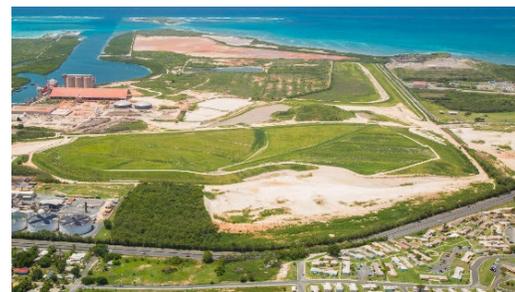
The site underwent a “test” one year following construction completion. Hurricane Maria, a Category 5 hurricane, passed 30 miles (48 km) southwest of site on Sept. 19-20, 2017. With sustained winds of over 100 miles per hour (160 kph) gusting to 136 miles per hour (220 kph), it knocked out all rainfall gauges on-island including the on-site weather station. 10.5 inches (26.7 cm) of rainfall was the last recorded total at the airport next to the site on Sept. 19, 2017. The heaviest rain was likely on Sept. 20, 2017 with rain lasting several days. Nearby Puerto Rico experienced rainfall up to 38 inches (96.5 cm)¹. Post-hurricane inspections indicated that the site experienced substantial stormwater. Inspections additionally showed no channel erosion in critical channels protected with TRM and only minor erosion in one area of unprotected channels.

Photo 5. Area A Site Post Remediation
