Investigation and Rehabilitation of Bridge Abutment MSE Wall Instability

Marshall B. Addison Ph.D., P.E.

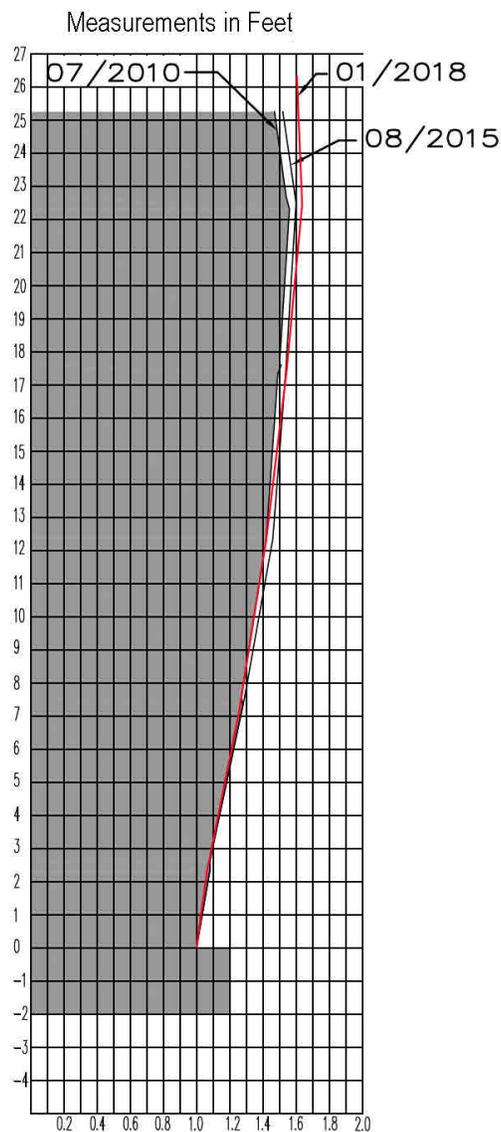
Early settlement of the bridge approach slab was determined to be a function of minor compression of foundation soils and embankment fill. Continued settlement was attributed to creeping pullout failure from inadequate passive resistance of the uniform, fine silty sand backfill to the horizontal bars of the mat reinforcement as the wall progressively tilted (see Figure 1).

The next efforts generally consisted of: selection of a cost effective remedial method that allowed the bridge to remain open. The chosen solution consisted of injections of sodium silicate, in a permeation chemical grout method, to improve passive resistance of the reinforced zone. A qualified contractor was chosen and determination of in-place stiffness of wall backfill in a test section before and after injections was performed. Computer modeling was performed to determine the minimum amount of grouting necessary to increase the long term Factor of Safety (FS) to acceptable limits. Determination of a permeation grouting program including materials, methods and injection hole spacing was finalized to develop a safe and long term solution.

Detailed construction plans and specifications for permeation grouting of the MSE sand backfill zone with sodium silicate chemical grout were developed and the injection operations were monitored. Post grouting DDCP was monitored to meet acceptance criteria. Numerous construction details were specified and built to return the site to conventional ride ability after grouting. Survey monitoring of the wall occurred more frequently during the evaluation and remediation periods. Monitoring was terminated after approximately eight years of satisfactory wall and pavement performance.
