Reconstruction of Failed Roadway Embankments Using Tire-Derived Aggregate Mechanically Stabilized Earth Walls: Ortega Ridge Road MS-TDA Case Study

ORTEGA RIDGE RD MS-TDA WALL - LOCATION

PROJECT LOCATION:
Town of Summerland
Santa Barbara County
State of California

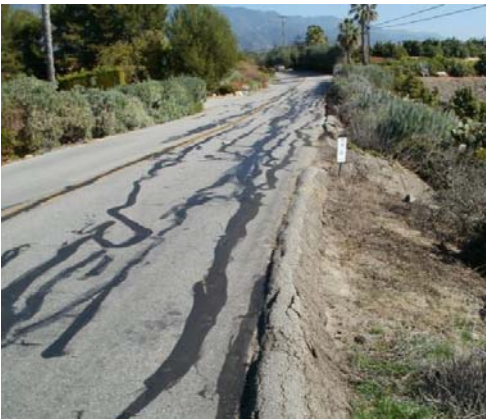
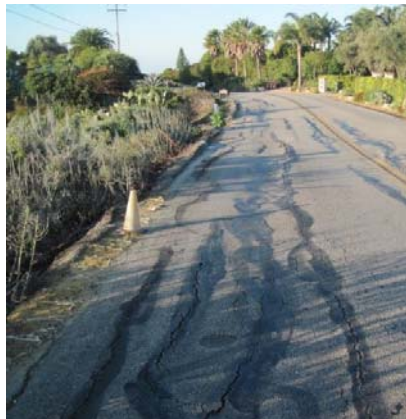
Existing Conditions – Summer 2015

- Sloughing and Settlement of weathered shale embankment soils
- Maintenance: Crack-sealing and Asphalt overlays over several decades
- Over 30" of Asphalt at the downslope edge of pavement.
- Failing HMA Dike allows storm water to drain over slope.

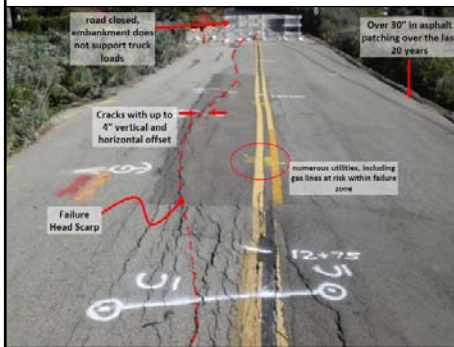
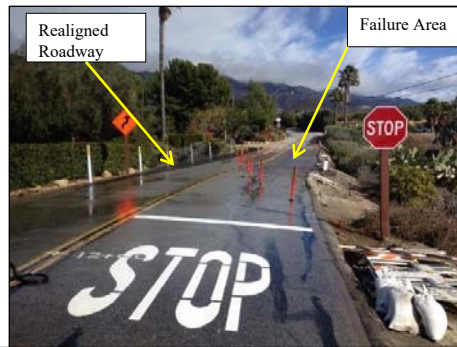
Existing Conditions – November 2015

- More Asphalt overlays to smooth out cracks for driver comfort and safety.
- Sloughing and Settlement of weathered shale embankment soils accelerate and failure extends further into far lane.
- Road Closed to all traffic for a period of 2 months.
- Temporary roadway realignment, additional 7 FT of pavement, and alternating stop-controlled single traffic lane constructed.
- Utilities within failure area – no known impacts (flowing by)

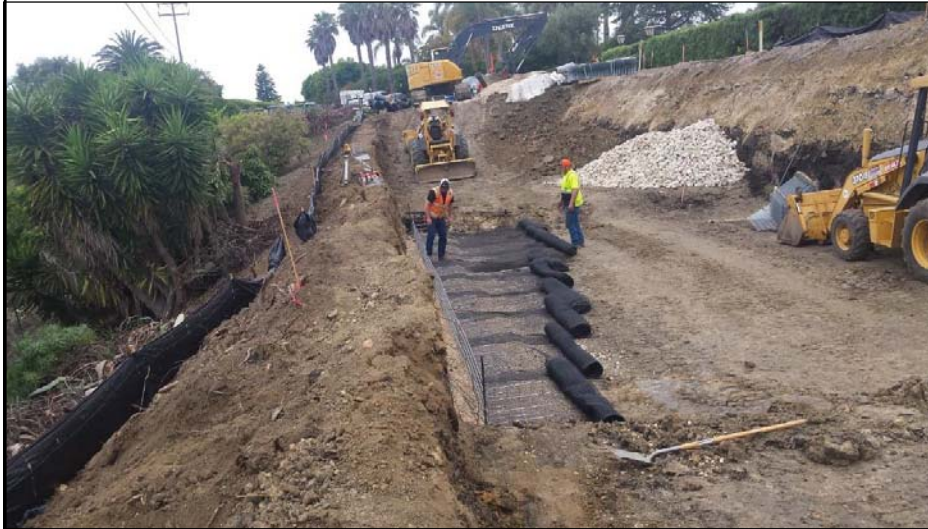
Placing the first level of MSE Wall welded wire facing on engineered fill, and placement of Tensor UX1100 (or equal) uniaxial geosynthetic reinforcement.

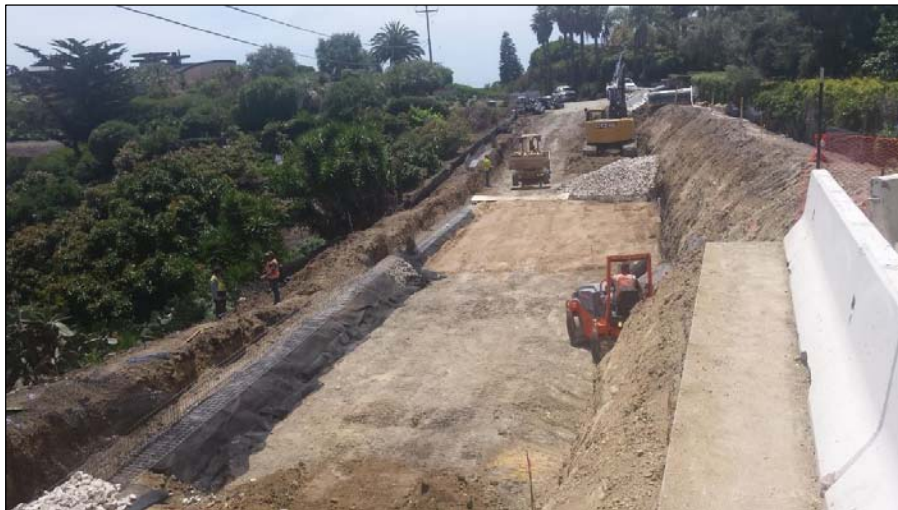
Placement of engineered fill, first level of MS-TDA Wall facing, stone fill, and Geosynthetic reinforcement.

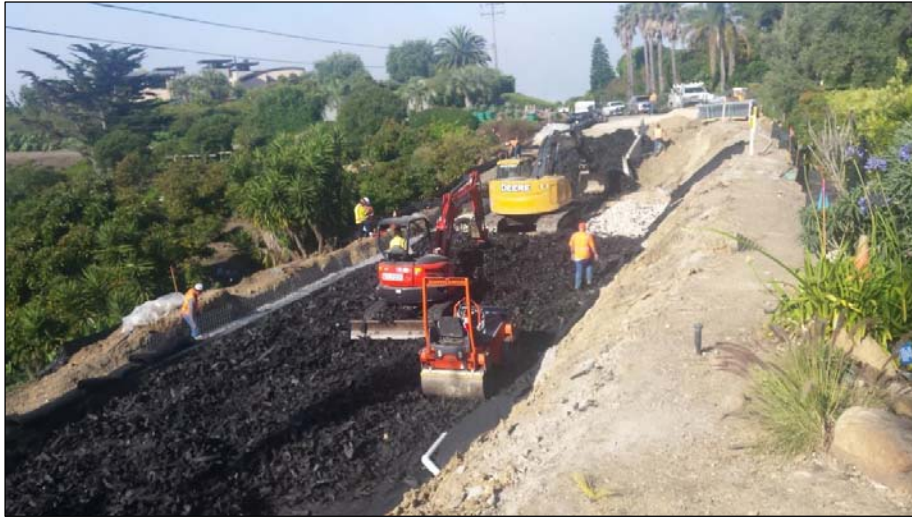
Contractor initially used smaller, lighter equipment to move and place TDA. Rubber tired equipment is not suitable, as the TDA and steel strands will often puncture tires or otherwise foul up the equipment. Tracked equipment and smooth drum rollers are required.

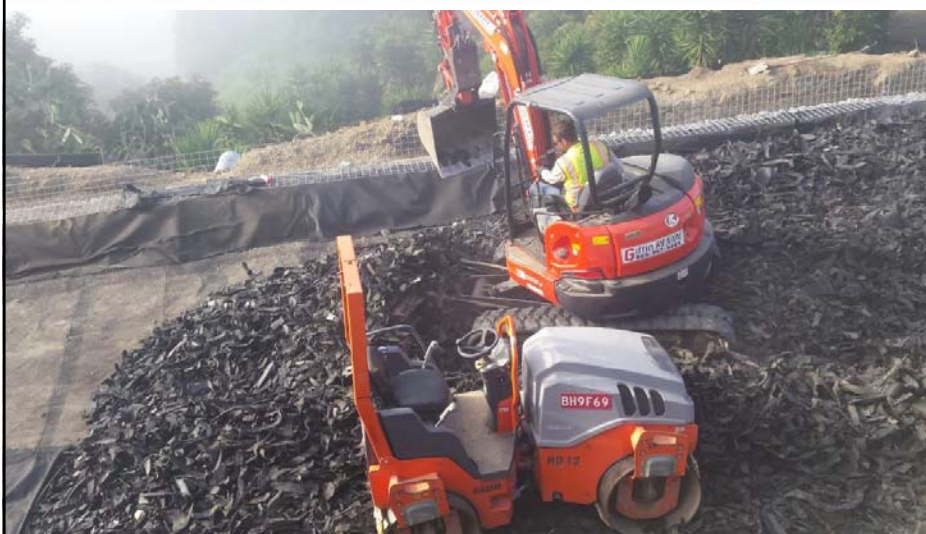
Lighter equipment is required within the first 5 FT of the retaining surface, so as not to damage facing and geosynthetic reinforcement connections.

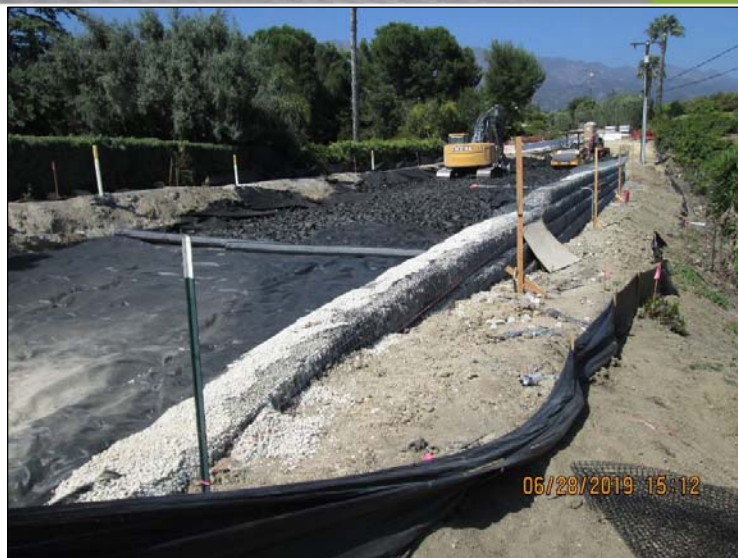
Subgrade Enhancement Geotextile (**TerraTex HPG-16ca**) is placed on top of the TDA prior to engineered fill placement.

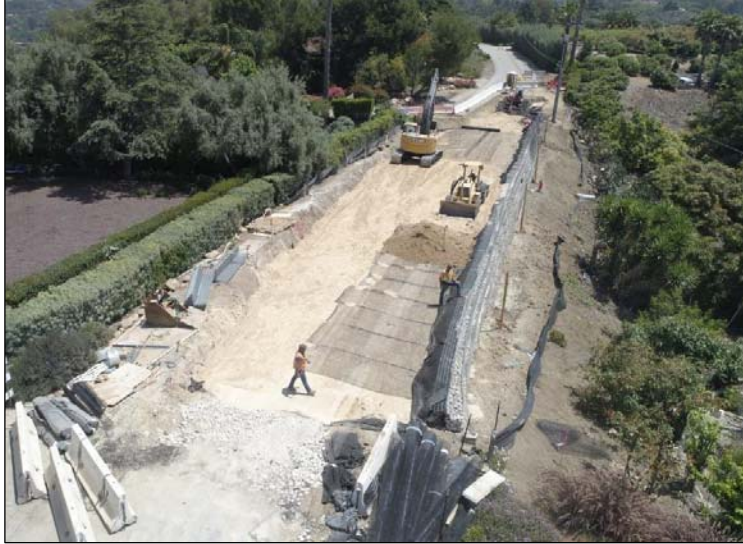
3 FT of engineered fill is brought on top of TDA, to bridge over material and provide stable base for structure section. Tensar UX1100 (or equal) specified. TerraGrid U350 Used.

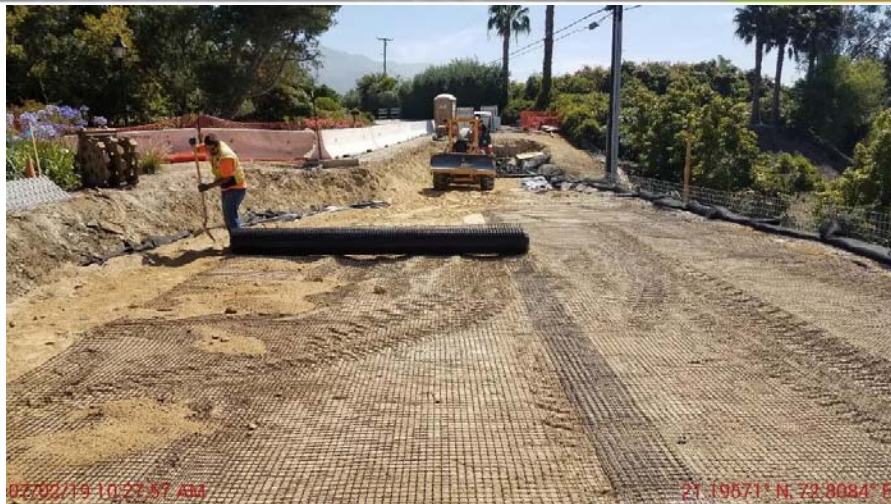
2 layers of biaxial geosynthetic reinforcement are placed within engineered fill to full width of excavation. Tensar BX1500 (or equal) was specified. TerraGrid SX3030 used.

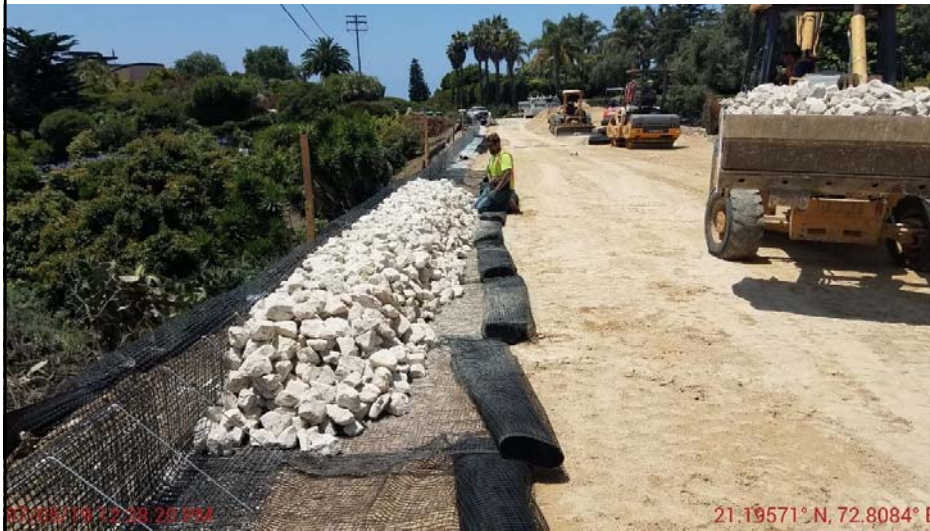
Final Level of MSE Wall and rock fill is placed. TerraGrid RX1100 biaxial geogrid was used to line the back of the welded wire facing, as contractor utilized facing aperture and rock size were not entirely compatible...

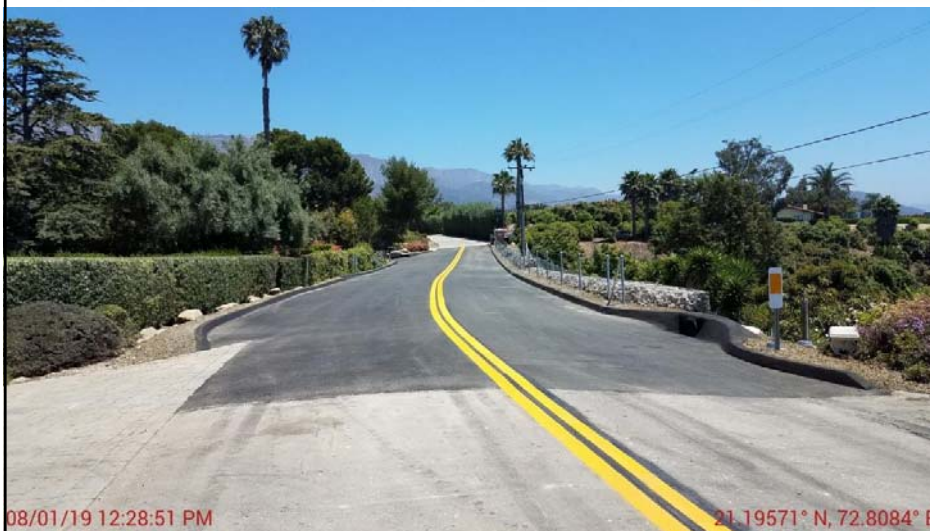
Completed project, open for traffic.
