The 2023 Koerner Lecture

**FROM ZERO LEAK  
AT END OF GEOMEMBRANE INSTALLATION  
TO ZERO LEAKAGE  
IN SERVICE**

By  
**J.P. GIROUD**

2023 February 07

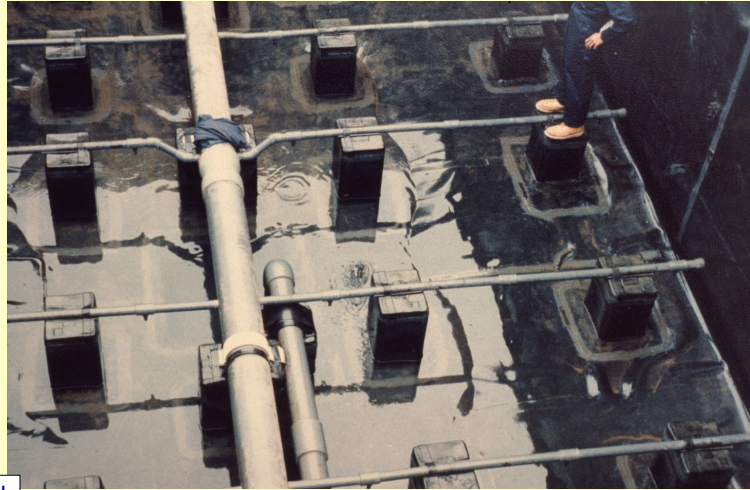
And the installed geomembrane . . .

. . . had more than 100 holes.

- The configuration of the reservoir was such that it was **inevitable to have many holes** in the geomembrane.
- Clearly, the cause of the holes was the **inadequate design**.

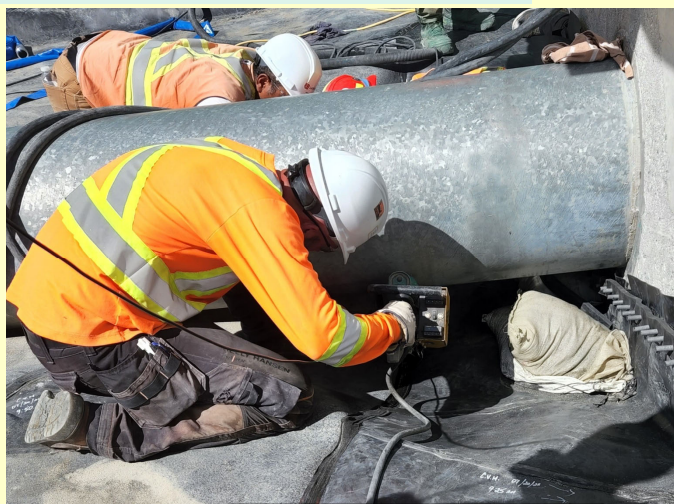
**Excessive leakage** occurred in this reservoir and **extensive rework** was necessary.

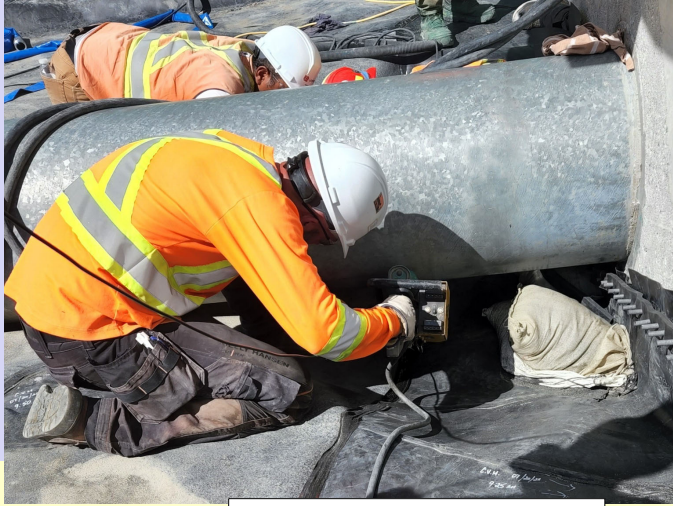
Thanks to the rework, the leakage was significantly reduced, but not reduced to zero, even though the installer was excellent and an expert field engineer was present.

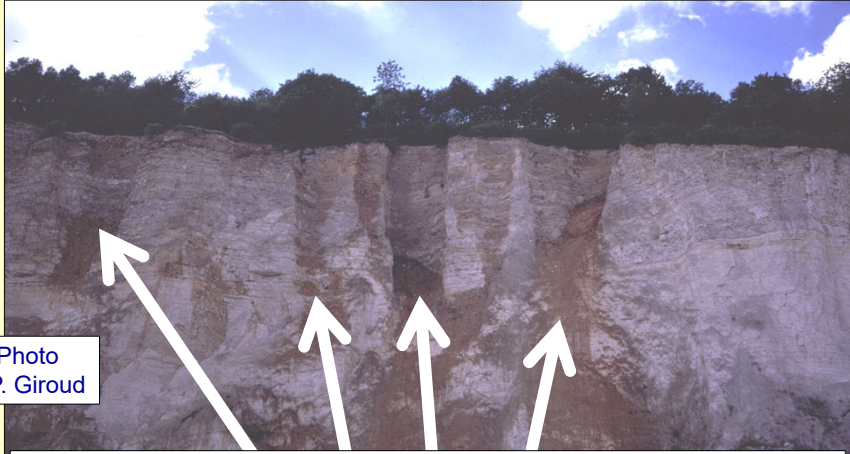
Here is the quarry showing a cross section of the karstic formation.

Numerous cavities could be observed.

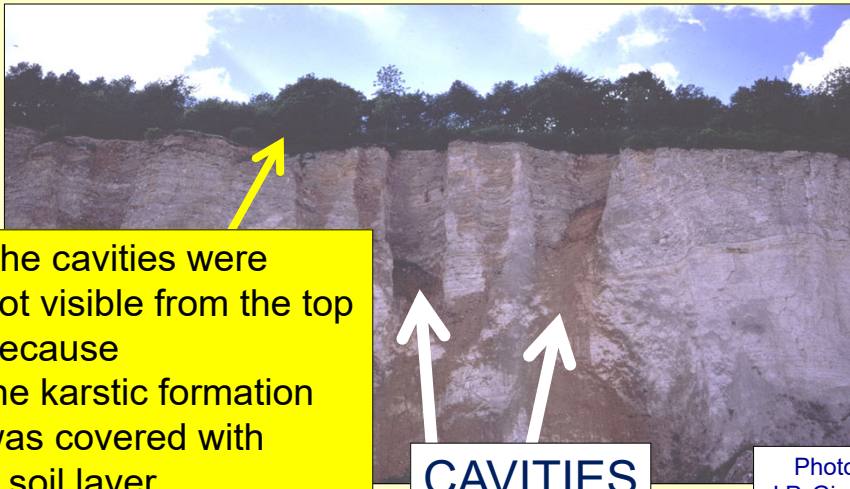
CAVITIES

The reservoir was located on the top, behind the trees, not far from the quarry.

The cavities were not visible from the top because the karstic formation was covered with a soil layer.

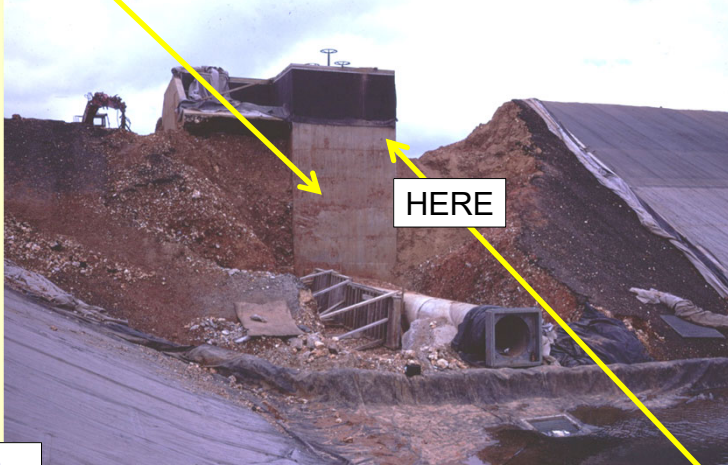
Here is a view of the failure area showing the concrete structure to which the geomembrane was attached.

The defective connection was here.

Clearly, the **failure** mechanism was **initiated by leakage** into the ground.

- A **detail** (poor connection) **triggered the failure**.
- But the **cause of the failure** was a **conceptual design flaw**: the leakage collection and detection layer **without a secondary liner**.
- And there was **negligence** regarding **soil investigation**.

Therefore, the solution was to achieve a *leakage rate into the ground* as close as possible to “**zero leakage**”.

The adopted repair solution included both **double liner** and **reinforcement**.

- The key aspect of the repair was the **double liner**, because it addressed the **cause of the problem**, which was *leakage into the ground*.
- The **reinforcement** only addressed the **consequence of leakage**, which was erosion of geomembrane support. (*It was used to reassure the owner who did not trust the double liner.*)

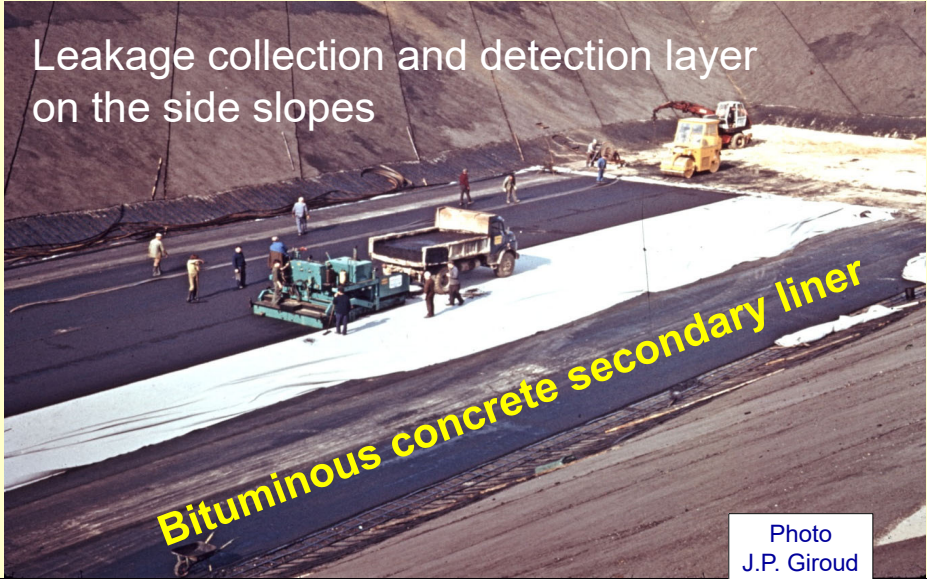
**CONSTRUCTION OF THE REMEDIATION**

Leakage collection and detection layer  
on the side slopes

Bituminous concrete secondary liner

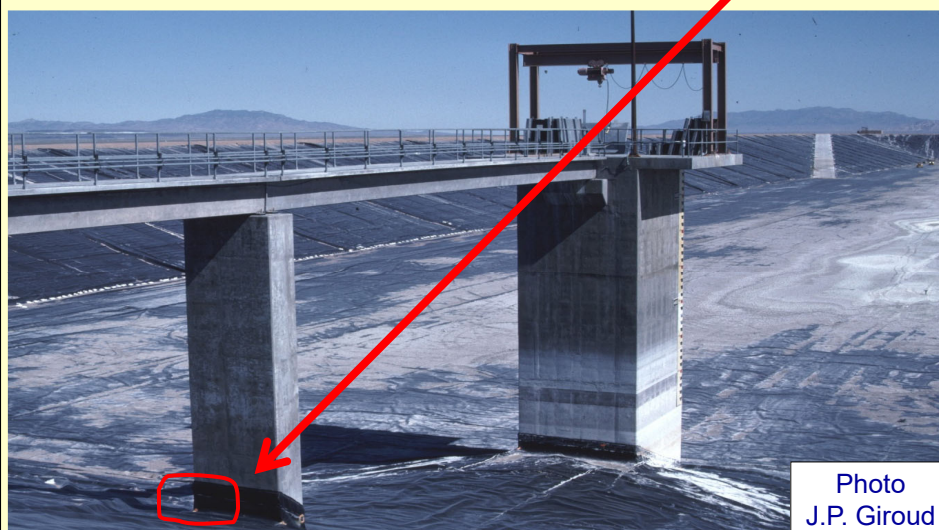
The geomembrane failure occurred here,  
at the toe of a concrete structure.

Even if there is **zero leak**  
at a geomembrane-structure connection,  
at the *end of geomembrane installation*,  
**leakage may occur in service**  
due to failure of the geomembrane  
caused by concentrated stresses  
induced in the geomembrane  
next to the structure.

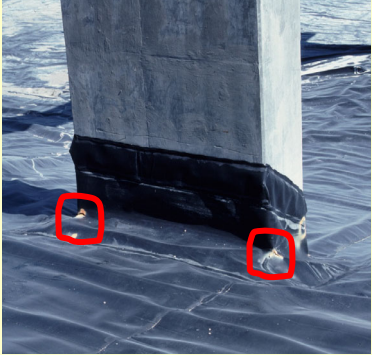
In addition to the risk of **stress concentration**, there is **another problem** with **right-angle corners**.

It is difficult to achieve a **watertight** connection between a geomembrane and a structure with **right-angle corners**.

Without watertight connections, the **zero-leak goal** at end of installation **cannot be achieved**.

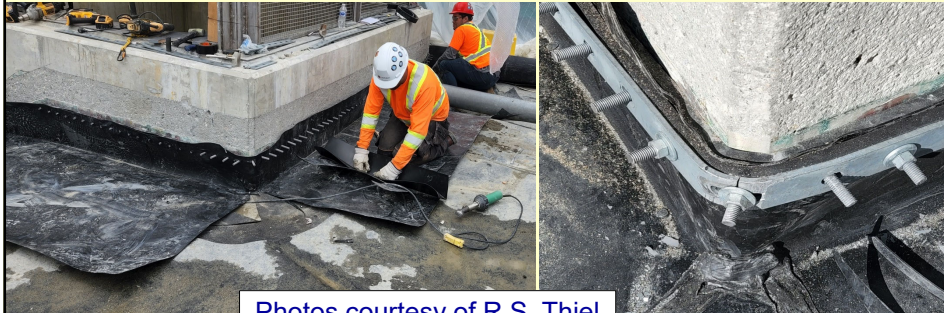
These photos illustrate  
the **amount of care** needed  
to attach a geomembrane  
to a concrete structure  
with **right-angle corners.**

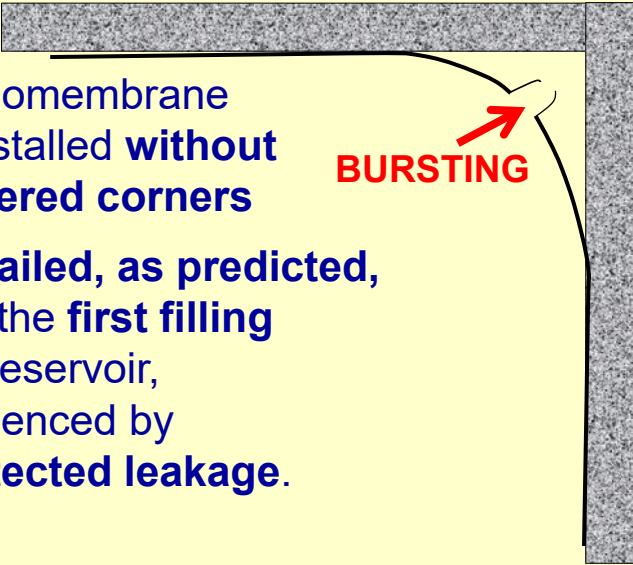
**BURSTING**

The geomembrane was installed **without chamfered corners** and it **failed, as predicted,** during the **first filling** of the reservoir, as evidenced by the **detected leakage.**

The **remediation** consisted in constructing the **chamfer** that had been initially recommended.

- Lightweight **concrete** was slowly poured **in the corners** between the rock-salt wall and the secondary geomembrane, thereby *using the geomembrane as a form*, **while water was progressively added** in the reservoir, as needed to balance the fresh concrete pressure.
- The reservoir was thus successfully repaired and filled with water at the same time.

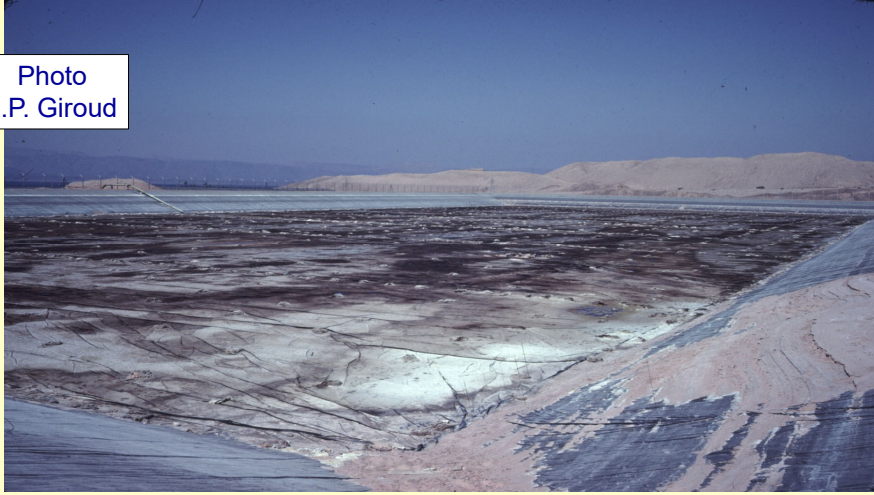
- A large reservoir containing **acid** was constructed on a soil with a high **calcium carbonate** content.
- It was lined with a geomembrane installed **without construction quality assurance**.
- **Acid leaked** through the **many holes** in the geomembrane and attacked the calcium carbonate, thereby creating **cavities**.

The reservoir emptied after the geomembrane **burst** over several **large cavities**.

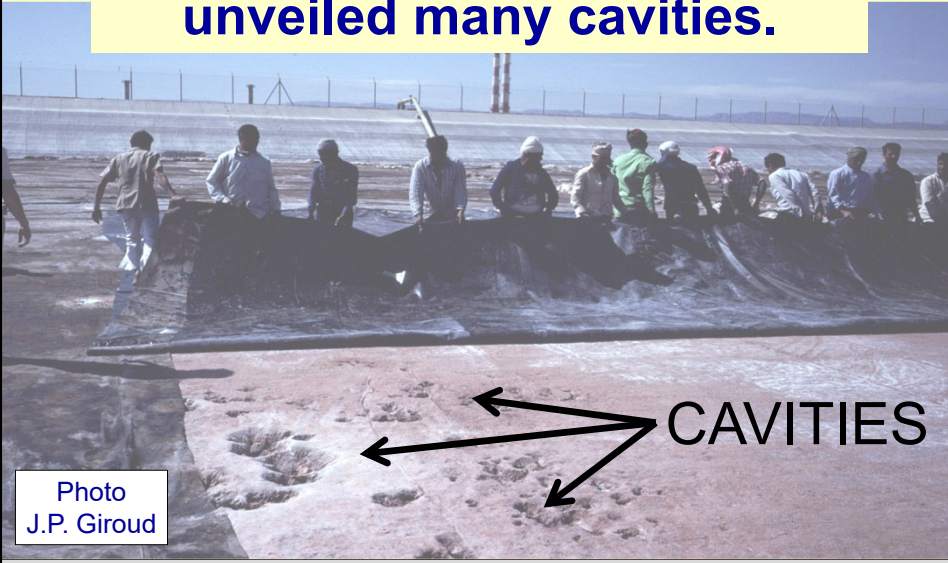
**CAVITIES**

**Removing the geomembrane unveiled many cavities.**

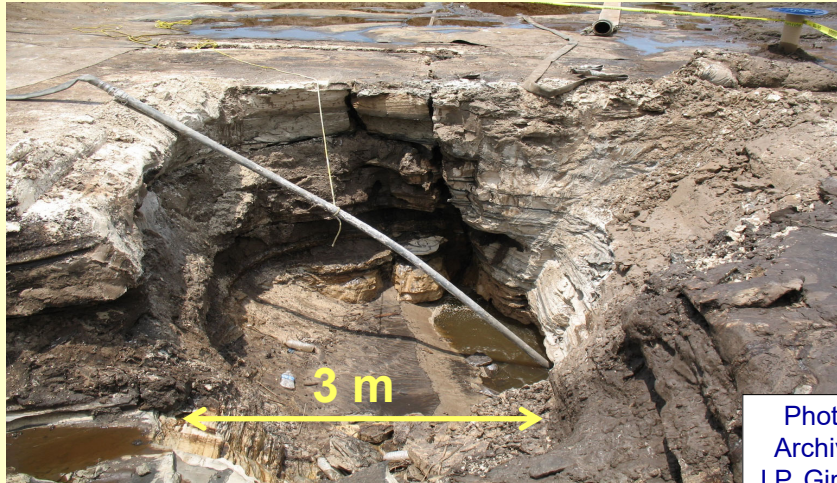
A large cavity, 20 m<sup>3</sup>,  
had developed **under the geomembrane**,  
at the bottom of the reservoir.

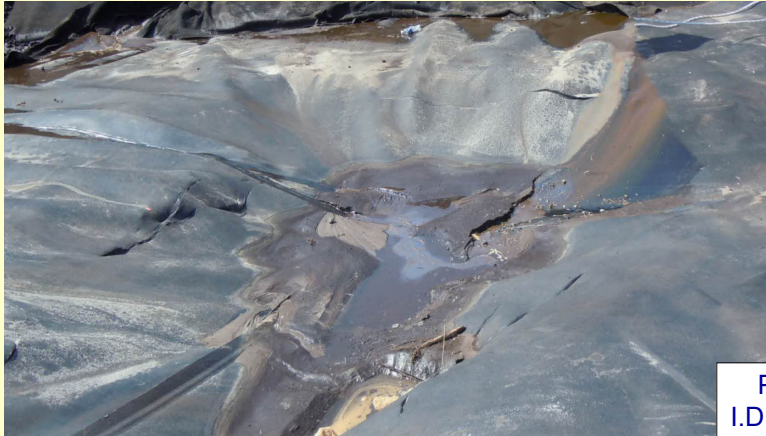
The geomembrane **burst over the cavity**.

Here is a photo of the geomembrane  
ruptured **over the cavity**.

These 35 days are **consistent** with  
leakage rate **calculations**,  
and with the **calculated time** required  
for the leaking water  
to dissolve 20 m<sup>3</sup> of that soil.

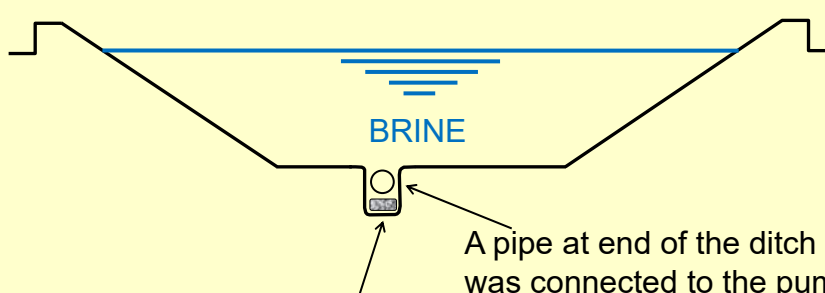
A long ditch was used as a sump to pump the brine.

The geomembrane was ballasted at the bottom of the ditch.

Therefore, the geomembrane could not move at the bottom of the ditch, but could move elsewhere since it was not covered.

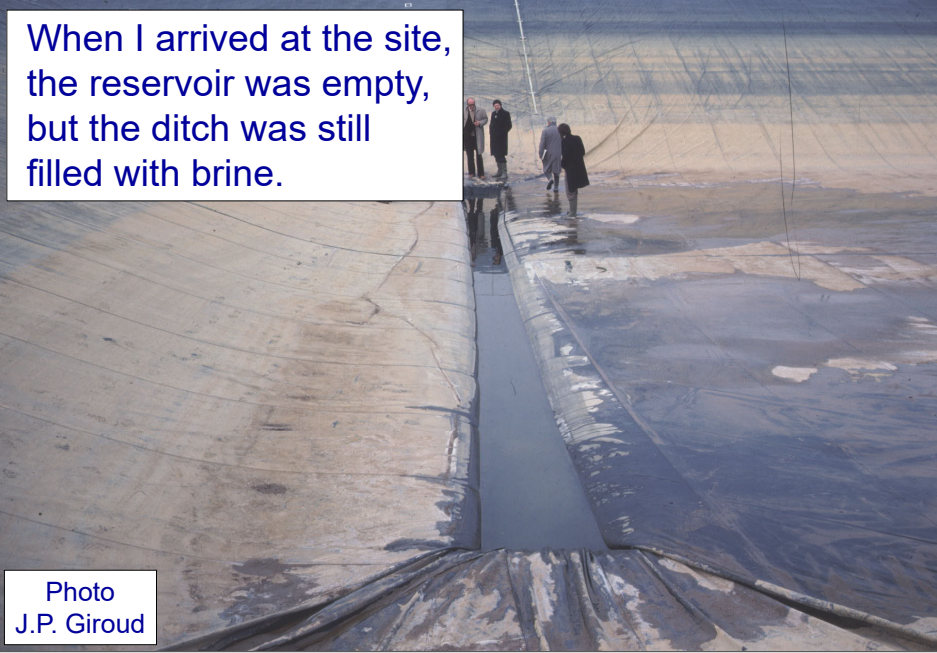
When I arrived at the site, the reservoir was empty, but the ditch was still filled with brine.

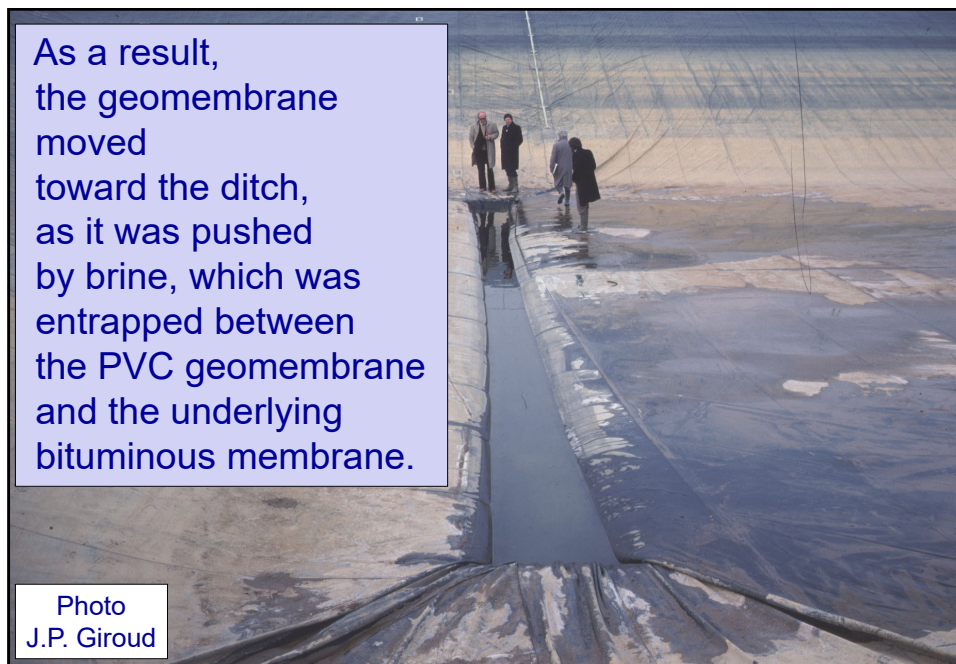
As a result, the geomembrane moved toward the ditch, as it was pushed by brine, which was entrapped between the PVC geomembrane and the underlying bituminous membrane.
