Rebuilding Mountains with Expanded Polystyrene

Brendan Stepek, EI¹

¹Schnabel Engineering LLC, 11A Oak Branch Drive Greensboro, NC 27407;

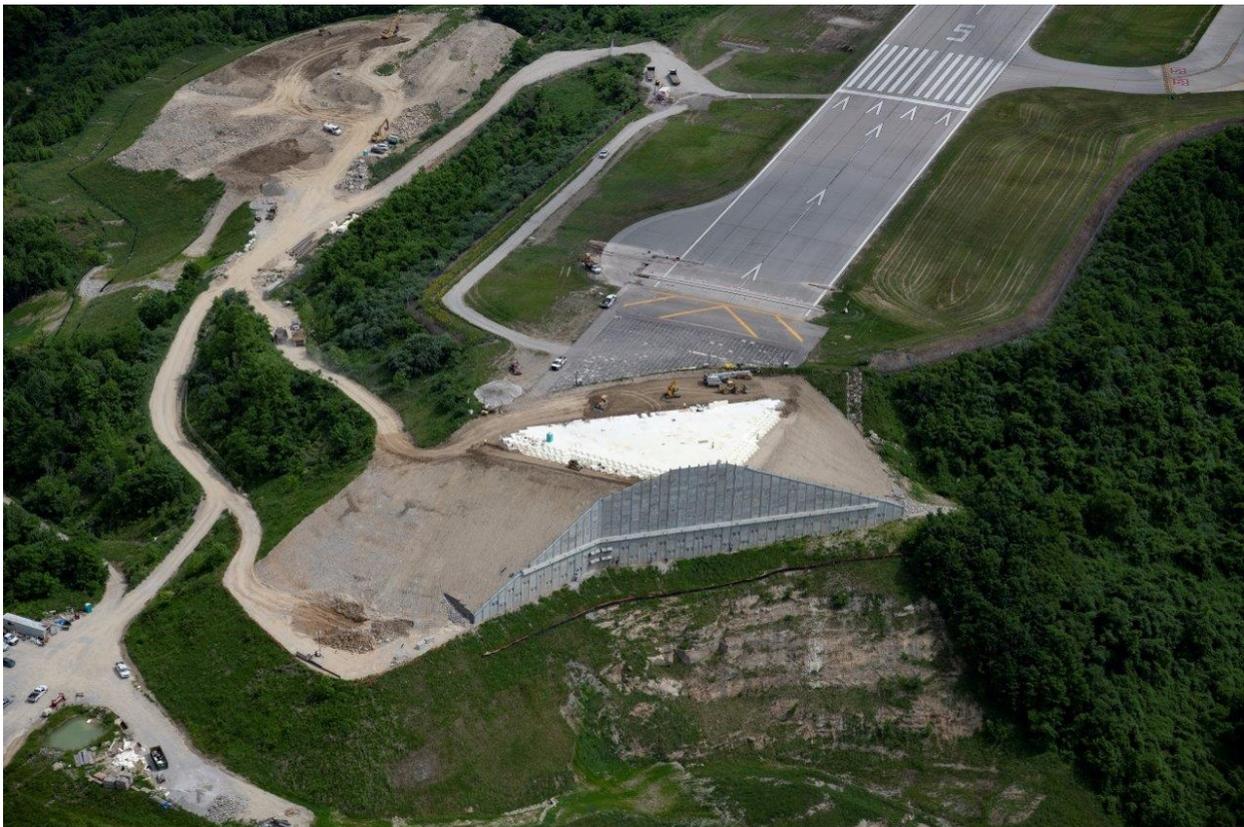
Figure 1. Aerial view of EPS backfilled retaining wall at Yeager Airport

The EPS fill mass was installed by Orders Construction Company. With very limited staging area, the EPS block installers had to use a creative and highly coordinated effort to place approximately 6,000 EPS blocks at the end of an active runway. The installation of the blocks took approximately 3 months. The placement of the EPS blocks had to be balanced with other project structural elements including conventional fill adjacent to the EPS.

In July 2019, the rebuilding of the fill at the end of Runway 05 was completed. The reestablishment of an emergency aircraft safety area allowed Yeager Airport to be fully in compliance with Federal Aviation Administration safety requirements. The use of Expanded Polystyrene as a lightweight fill material allowed for a more economical and better performing wall system.
