Performance of High-Strength Geogrid In Reinforced Soil Slope and the Yeager Airport

Robert C. Bachus, Ph.D., P.E., D.GE,¹ and John M. Lostumbo, P.E.,²

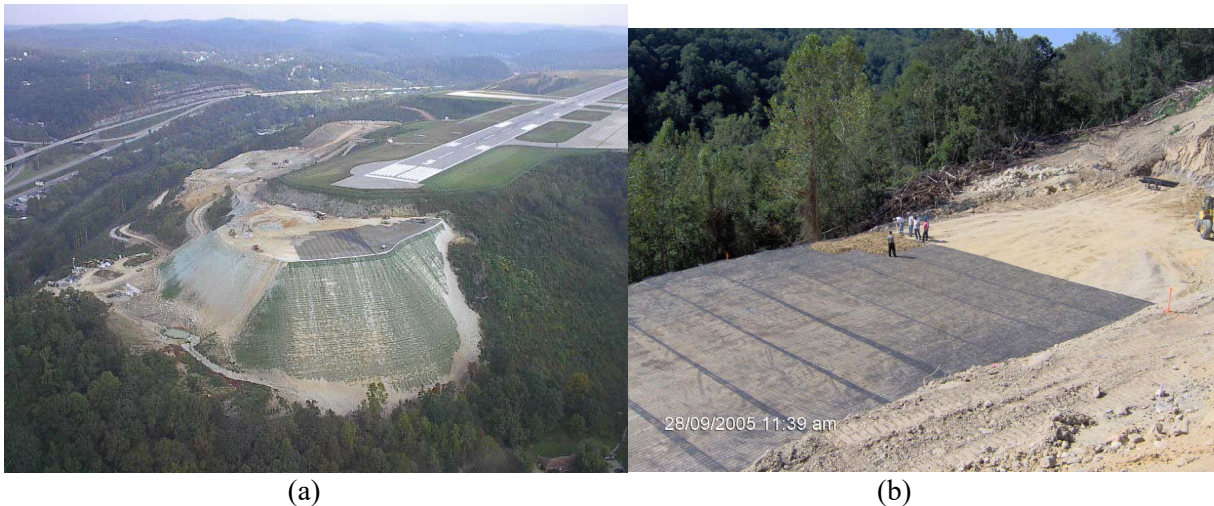
Figure 1: Photograph of RSS Nearing Completion (a) and During Construction (b)

The extension of Runway 5 at Yeager Airport in Charleston, WV required the construction of a 74-m tall, 1 horizontal to 1 vertical (1H:1V) reinforced soil slope (RSS). The RSS was needed due to lack of the requisite contiguous land necessary to extend the length of the runway to meet Federal Aviation Administration (FAA) safety requirements. The RSS alternative was selected as a technically feasible and cost-effective strategy to lengthen the runway and allow installation of an innovative engineered materials arresting system (EMAS) at the end of the runway. Erosion control geosynthetic materials were used at the face of the RSS to provide an aesthetic “green” slope face to allow the RSS to blend into the natural hillside. The project was completed in 2007, and at the time of completion, it represented the tallest RSS in the world. A photograph of the project nearing completion is presented in Figure 1a to show the embankment being constructed; the geogrid being installed, and the erosion control facing.

In March 2015, nearly eight years after completion of the project, portions of the RSS failed. Forensic investigations and analyses were performed to assess the potential causes of failure. These investigations allowed an evaluation of the performance of the various engineered systems for the project. Two of the critical components related to the RSS were: (i) the soils used for the construction of the embankment; and (ii) the high-strength geogrid used as primary reinforcement. A photograph showing installation of the geogrid during construction of the embankment is presented in Figure 1b.

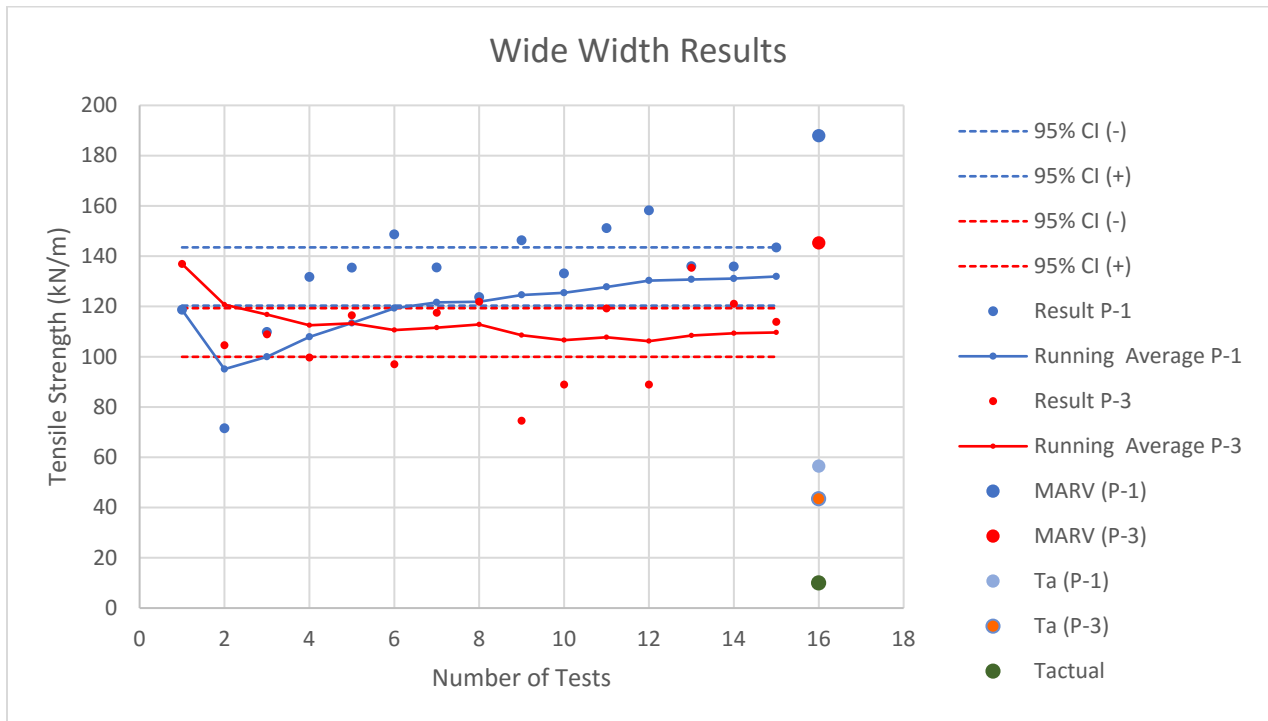
Figure 1: Results of Geogrid Testing of Exhumed Specimens

The project specifications identified the minimum ultimate tensile strength of the two geosynthetic reinforcements selected for design: (i) P-1 = 160 kN/m and (ii) P-3 = 123 kN/m. The selected high-strength geogrid for the project was a PVC-coated, high-tenacity polyester manufactured by TenCate Geosynthetics. The actual ultimate tensile strength (i.e., minimum average roll value or MARV) for both types geogrid exceeded the minimum project specifications. The minimum long-term design strength (T_a) after application of the relevant strength reduction factors was: (i) P-1 = 56 kN/m; and (ii) P-3 = 43 kN/m. Samples of both types of geogrid were carefully exhumed as part of the forensic investigation program. The results of wide-width tensile strength tests on the recovered specimens are presented in Figure 1. Results indicate that there was only minor strength loss in the geogrid despite the anticipated installation damage, nearly eight years of service in contact with the aggressive (i.e., large particle size) backfill soils and exhumation of the geogrid. In fact, the average tested strength values after exhumation were only slightly reduced from the original MARV and both high-strength geogrid materials still significantly exceeded the project design values for long-term design strength (T_a) and the calculated maximum mobilized tension (T_{actual}) in the geogrid, which was about 10kN/m. These results indicate that these flexible types of geogrid reinforcement products are extremely durable and retain tensile strength after installation stresses/damage and nearly eight years of service in an aggressive backfill.
