Reconstruction of Failed Roadway Embankments Using Tire-Derived Aggregate Mechanically Stabilized Earth Walls – Ortega Ridge Road Case Study

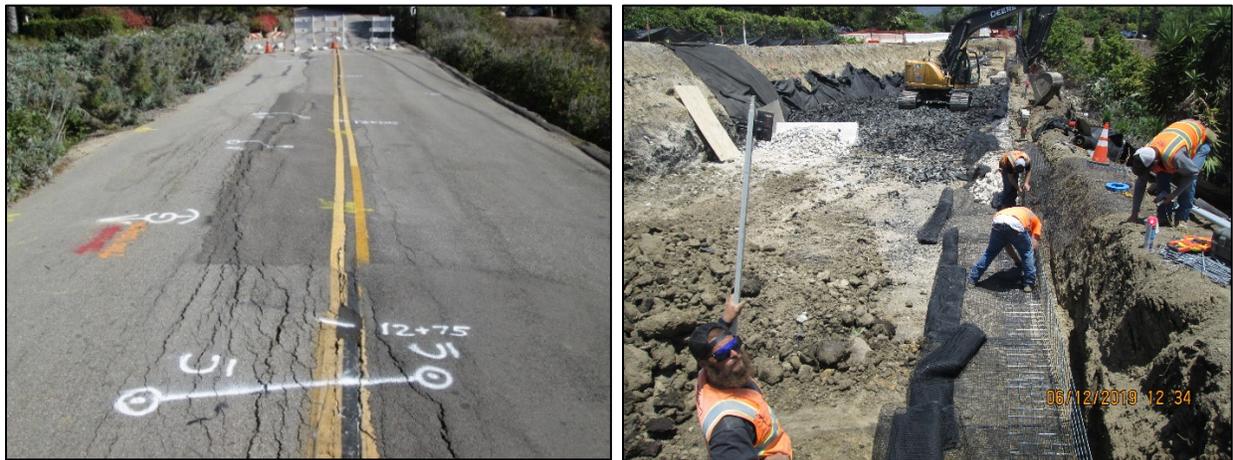
Photo 1. (Left) Arcuate cracking and failure of roadway surface prior to temporary realignment.

Photo 2. (Right) Installation of MSE Wall using TDA lightweight backfill (MSTDA)

Combining load-reducing TDA and geosynthetic reinforced MSE wall retaining units at this site allowed the County to construct a cost-effective long-term repair, with a smaller project footprint than traditional slope reconstruction techniques, while reducing the loading on the underlying expansive shale embankment. A 4.5 m (15 FT) high MSTDA wall with 0.9 m (3 FT) of toe embedment and a 72° wall batter, with geosynthetic reinforcement embedded 4.5 m (15 FT) into TDA fill at 0.45 m (18 in) vertical spacing.
