Innovative Geosynthetic Saves 100 -Year-Old Panama Canal

Abstract

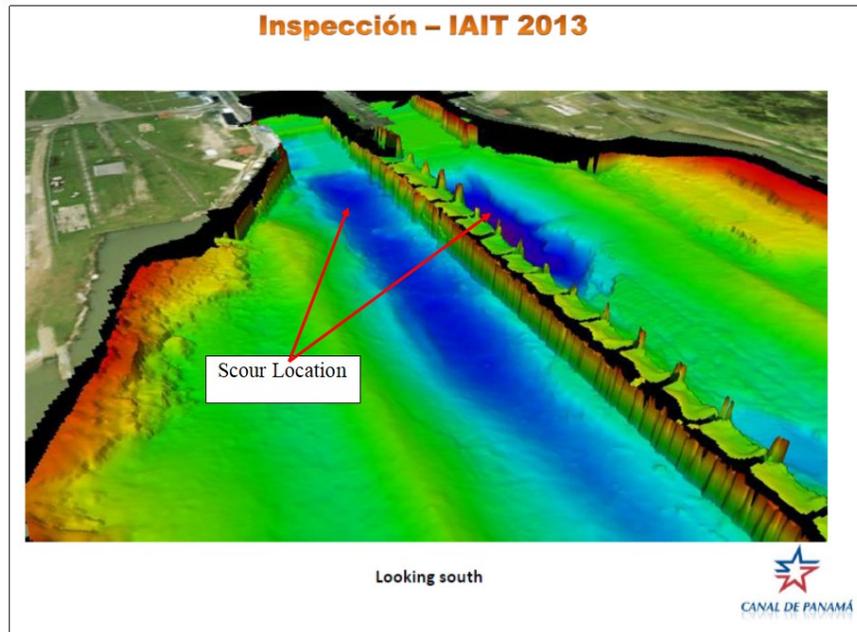
Figure 1. Scour Erosion Discovered in 2013 at the Gatun Locks Atlantic Entrance

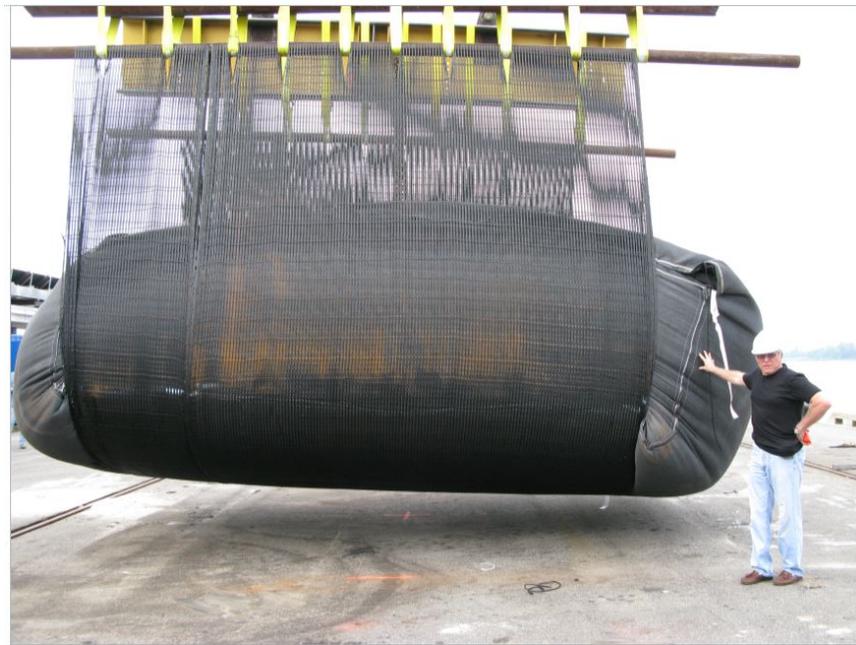
Figure 2. 90 Ton Geobag Lifted With 400 kN/m Geogrid

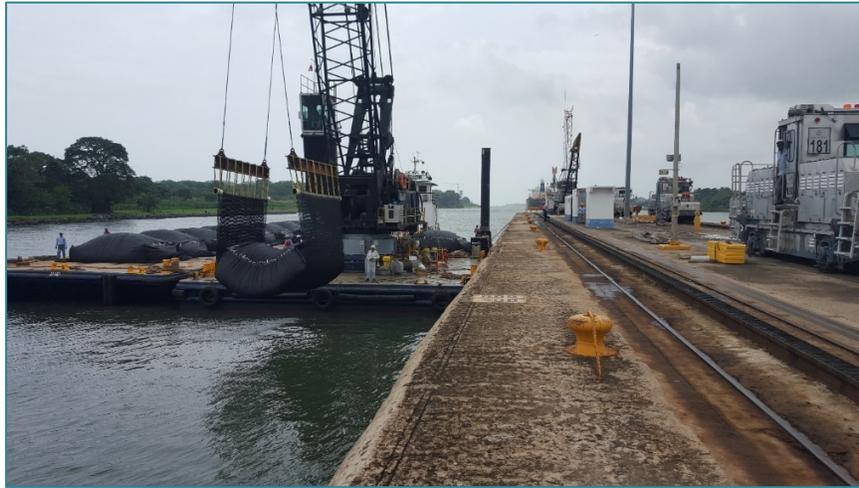
Figure 2. 90 Ton Geobag Prepared to be Placed in -20.0m of Water at Gatun Locks
