Maurice River and Johnson Creek Soil Bioengineering Stabilization and Restoration

TWO URBAN WATERWAY BANK REMEDIATION PROJECTS IN THE US

Maurice River in Millville, New Jersey.

Johnson Creek in Milwaukee, Oregon.

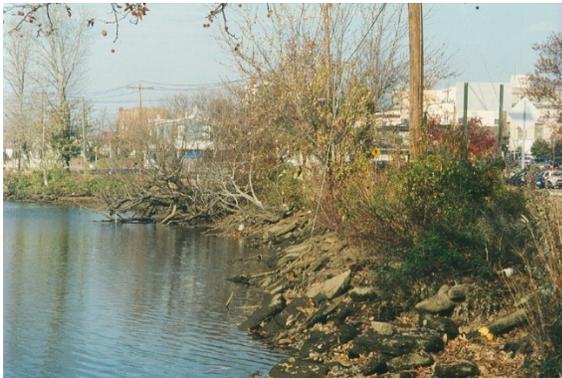
Figure 1. Bank conditions 2003

The Maurice River in this location is a tidal influenced system that had long been neglected and marginally stabilized with asphalt debris and concrete rubble. See Figure 1. In 2004 a new waterfront improvements program for the development of Ware Avenue Park and Marina presented an opportunity for soil bioengineering stabilization and restoration of the riverbank. A vegetated reinforced soil slope (VRSS) system that combined geogrid reinforcement and embedded rooted plant materials was installed. The geogrid soil wrapped upper lifts and vegetation stabilized the riverbank providing enhanced aquatic habitat and an attractive lineal park along the Ware Avenue Waterfront development. See Figures 2, 3 and 4.

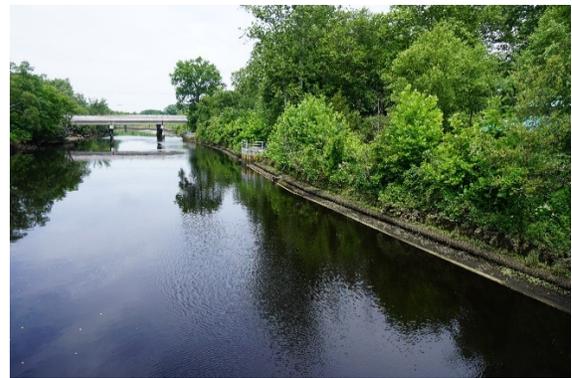
Figure 2. Bank conditions 2019

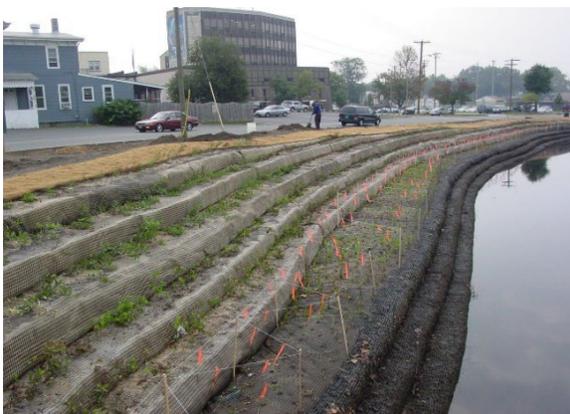
Figure 3. Post construction 2004

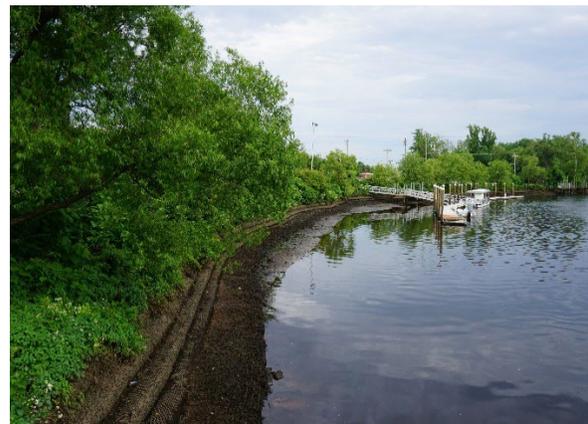
Figure 4. Bank conditions 2019

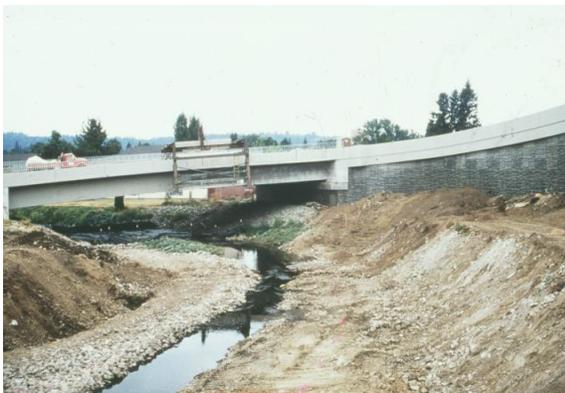
Figure 5. Original 1993 design for riprap

Johnson Creek flows through a highly urbanized suburban area of Portland. The creek was widened in the 1930's for flood control. In 1993 the creek was realigned, shortened and steepened by ODOT to accommodate a new bridge and off ramp highway construction. The initial proposal was for a trapezoidal riprap channel design. See Figure 5.

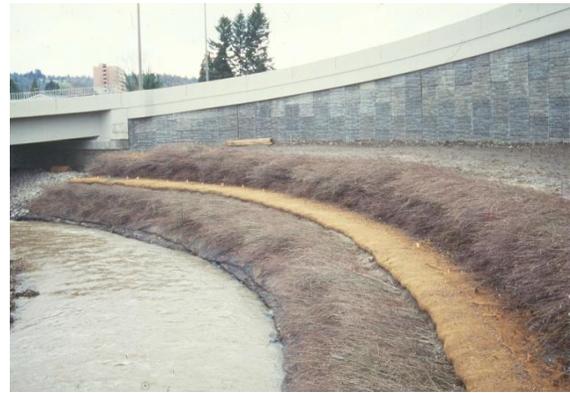
Figure 6. 2 weeks post construction 1994

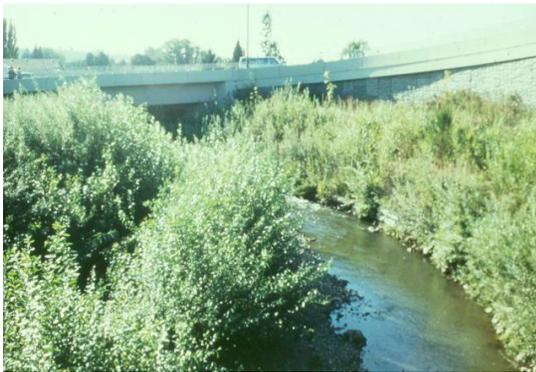
Figure 7. 6 years of development 2000

Due to environmental concerns and associated required permits for salmonid stream systems, the realignment and stabilization presented an opportunity for the use of ecologically sound soil bioengineering measures including the VRSS system along the outside right descending bank meander. A compound channel design was developed to provide a larger cross-sectional area to accommodate flood events and provide a wildlife corridor. See Figure 6. Beyond bank stabilization and channel stability, aquatic, riparian and waterfowl habitat and aesthetics were addressed to meet the multi-objective goals. See Figures 7 & 8.

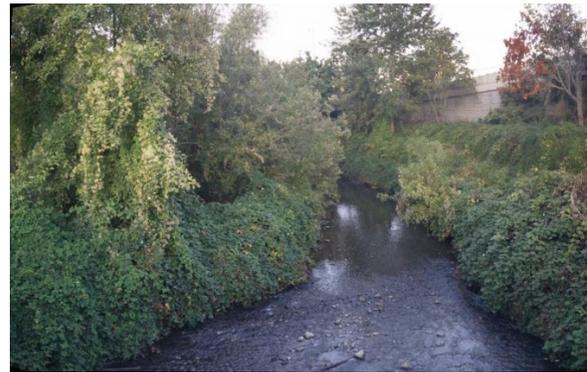
Figure 8. 25 years of development 2019
