# **A 60 m high Geogrid Reinforced Steep Slope for the Stabilization of a Landslide in Northern Italy**

**Cazzuffi, D.<sup>1</sup>, Recalcati, P.<sup>2</sup>**

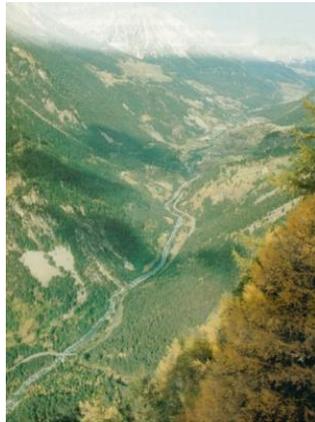
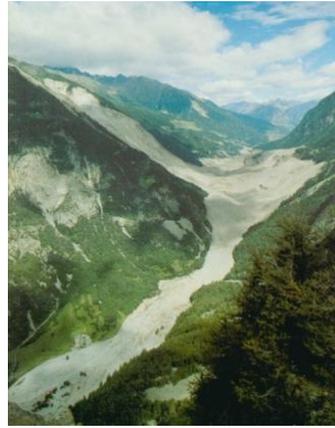
(a)

**Figure – a) aerial view before and after the landslide; b-c) construction phase; d) fire damage to the slope; e) present condition after assessing the fire impact.**

In July 1987, a major landslide occurred in Northern Italy that required significant remediation work. This paper presents the event details as well as the mitigation solutions that took place. More than 35-45 million cubic meters of rock avalanche collapsed, falling from the right hand side of the valley into the river bed, 1200 m below, and running up about 300 m on the opposite side. The landslide destroyed some villages directly underneath, while a catastrophic water and debris wave hit the villages located up to 1.0 km upstream along the valley. The landslide body created a natural dam 80 m high and 2.0 km long, completely closing the valley and thus creating an artificial lake behind it. The left hand side of the valley, not hit directly by the landslide, was covered by debris. The main goal that guided the design choices, was restoration of the valley's original shape before the landslide. It was necessary to reach the bottom of the river and excavate the deposited debris as much as possible and to the depth that was safely achievable, and to remove the debris on the left side of the valley. In order to avoid instabilities, the left hand side was reconstructed using temporary anchored sheet pile walls and soil reinforced slopes. The whole slope was reconstructed with 6 geogrid-reinforced slopes, each is 10 m high, separated by berms, totaling a height of 60 m. The slope inclination was 60° with a roadway over the base slope.
