A 60 m high geogrid reinforced steep slope for the stabilisation of a landslide in Northern Italy

Daniele Cazzuffi
CESI SpA, Italy

Piergiorgio Recalcati
TENAX SpA, Italy

Summary

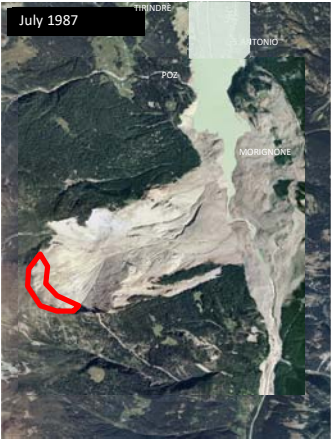
July 1987

A satellite image of a river valley in July 1987. The image shows a wide river channel with a large, light-colored, fan-shaped area of sediment or debris extending from the upper left towards the center. A red outline highlights a specific area on the left side of this fan. Labels 'TRINDRE', 'POB', 'MORBIANE', and 'MORBIANE' are visible on the image.

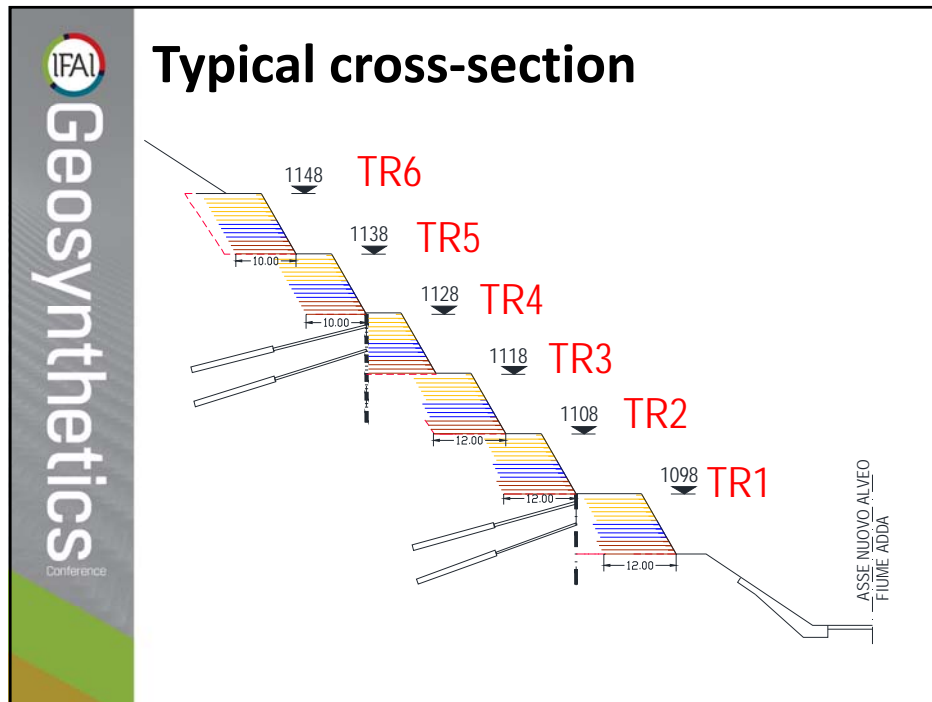
Reconstruction with a geogrid reinforced slope

- The whole area was reconstructed with 6 geogrid reinforced slopes, each 10 m high, separated by berms (total height of 60 m)
- A road was foreseen over the first slope
- Slope inclination 60° , spacing between geogrids equal to 700 mm
- Presence of micropile walls was neglected in analysis
- Internal, external and global stability analysis were performed
- Analysis carried out according to NTC '08 code (Italian Construction regulation code)

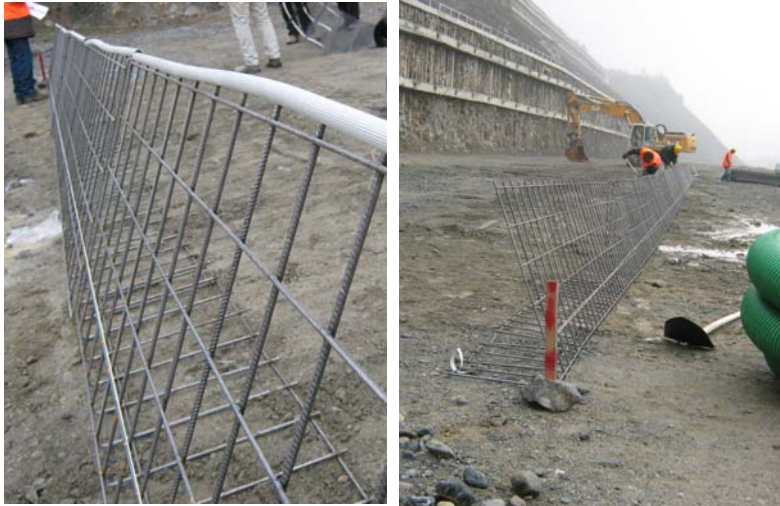
Sacrificial steel mesh formworks were foreseen because of the speed and easiness of installation

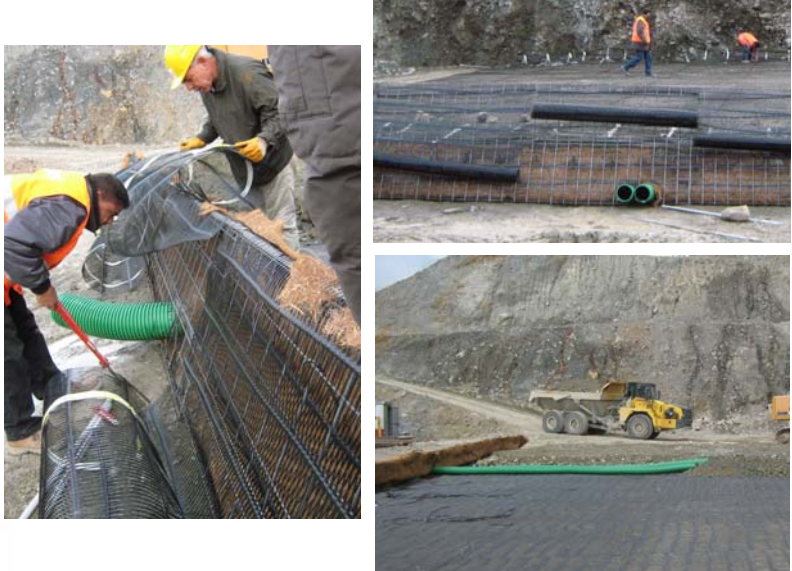
Accurate collection system and drainage of water was foreseen
