Maurice River and Johnson Creek Soil Bioengineering Stabilization and Restoration

Geosynthetics Conference
Charleston, South Carolina

Robbin B. Sotir
Robbin B. Sotir & Associates, Inc.

March 9, 2020

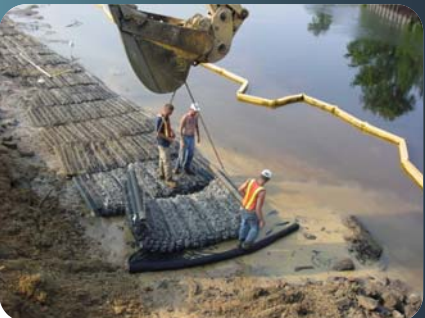
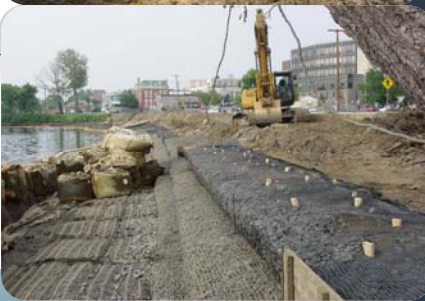
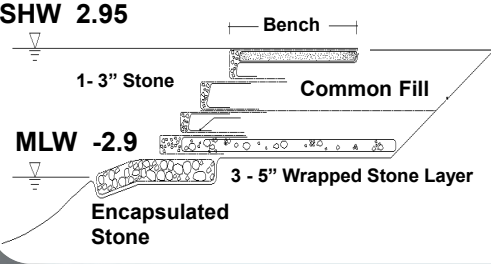
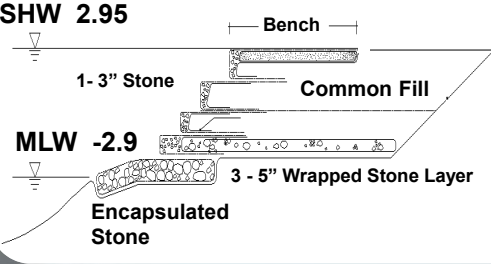
**Foundation: Geogrid & geotextile
wrapped stone & stone &
common fill lifts**

SHW 2.95

MLW -2.9

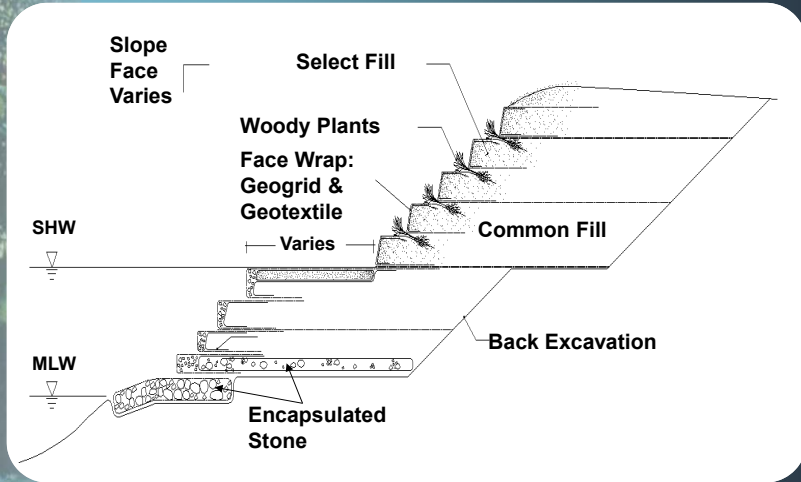
Vegetated Reinforced Soil Slope (VRSS) System
 1.5H - 1V to .5H to 1V

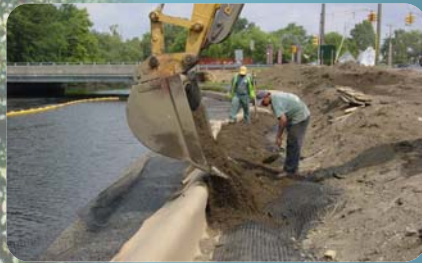
Geogrid, batter board & geotextile

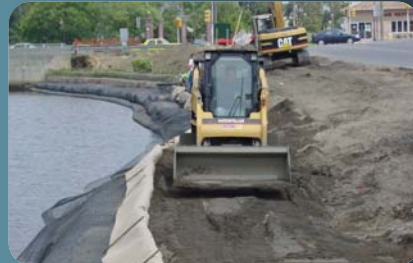
Select & Common fill

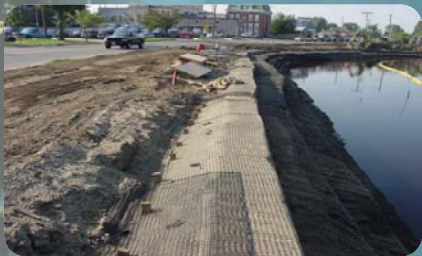
Secured geogrid & geotextile

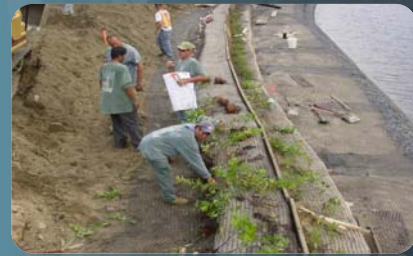
Plant installation

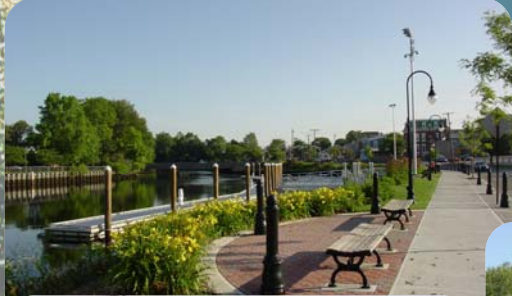
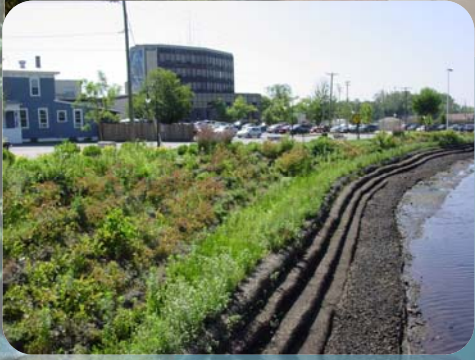
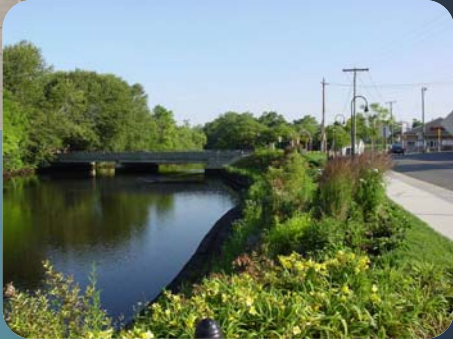
First Summer - 2005

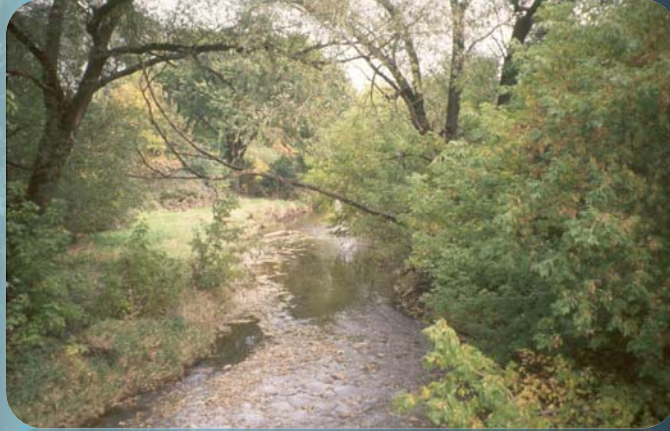
Pre-Construction Conditions:
Stable aesthetically beautiful & ecologically
functioning urban stream (fish migration)

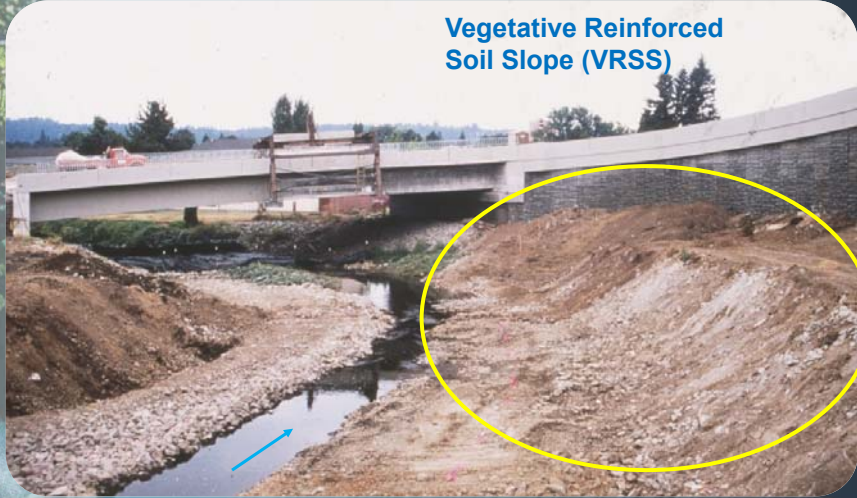
Vegetative Reinforced Soil Slope (VRSS)

Right Descending Bank

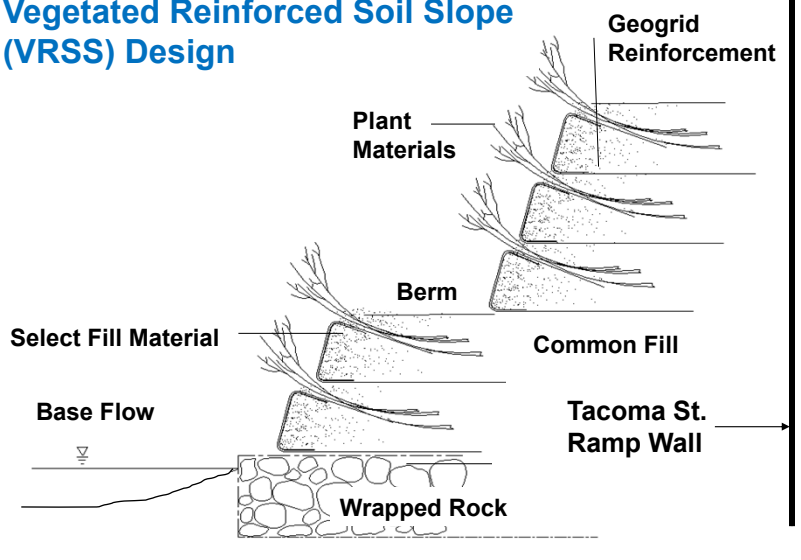
Vegetated Reinforced Soil Slope (VRSS) Design
