The 2023 Koerner Lecture

**FROM ZERO LEAK  
AT END OF GEOMEMBRANE INSTALLATION  
TO ZERO LEAKAGE  
IN SERVICE**

By  
**J.P. GIROUD**

2023 February 07

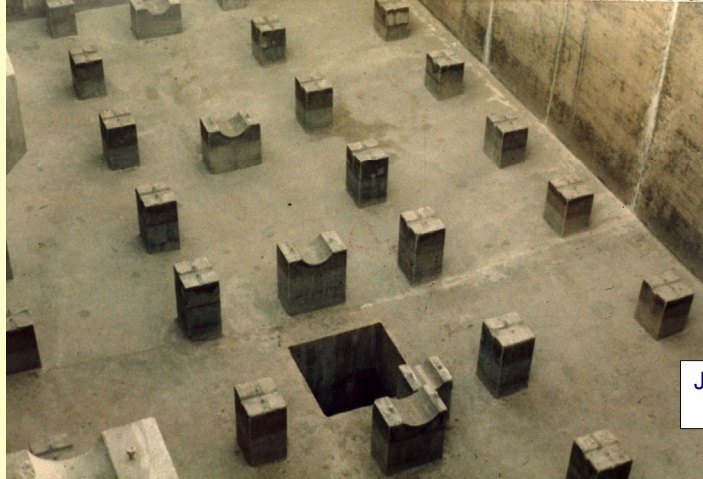
How is it possible to install a geomembrane  
in this concrete reservoir  
with so many pedestals ?

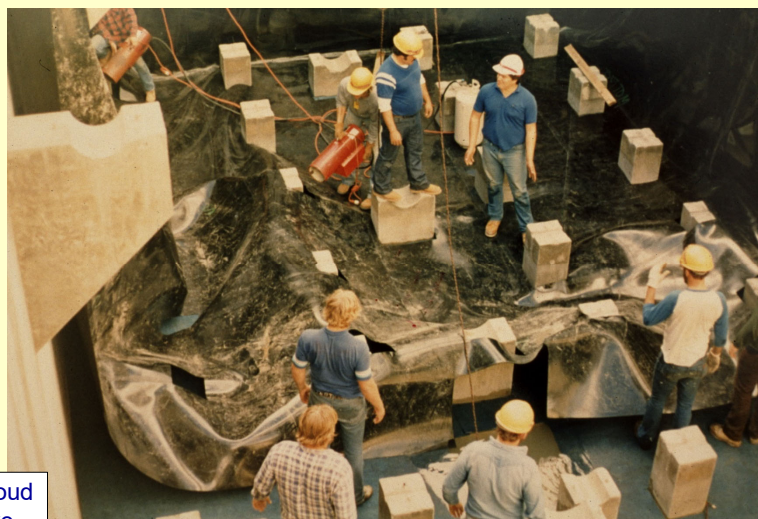
The answer is: with great difficulty.

- The configuration of the reservoir was such that it was **inevitable to have many holes** in the geomembrane.
- Clearly, the cause of the holes was the **inadequate design**.

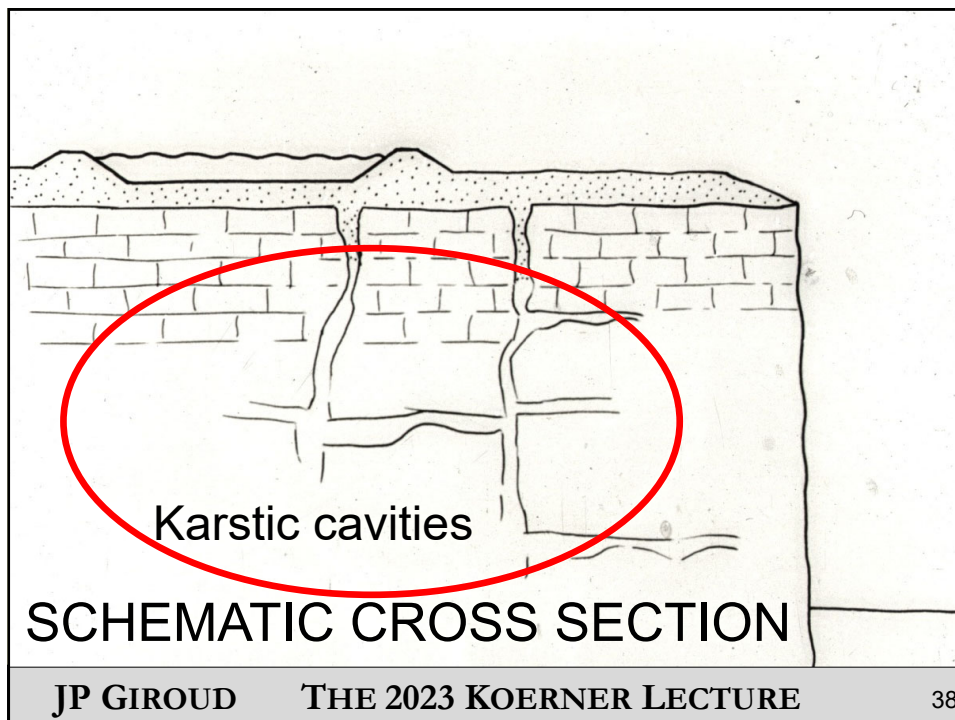
SCHEMATIC CROSS SECTION

- The reservoir was lined with a **single geomembrane**.
- The geomembrane was underlain by a gravel **leakage collection and detection layer placed directly on the soil**.

We will see that a **leakage collection and detection layer, placed directly on the soil, cannot prevent leakage into the ground.**

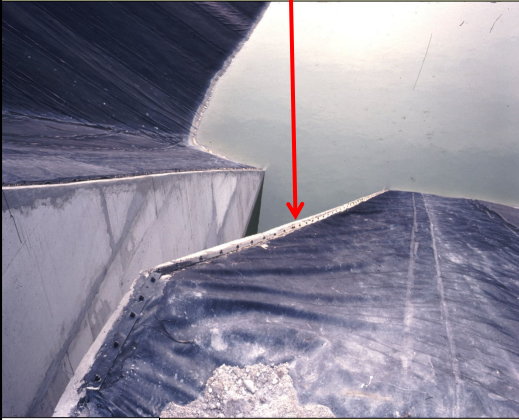
This wall moved toward the left . . .

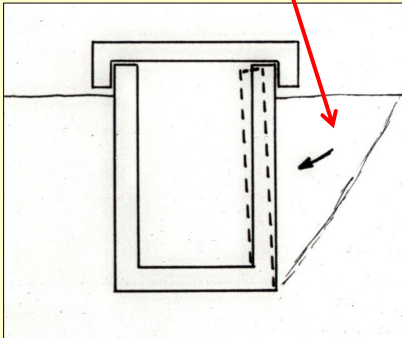
. . . because it did not resist the active soil pressure.

This was a **design error**.

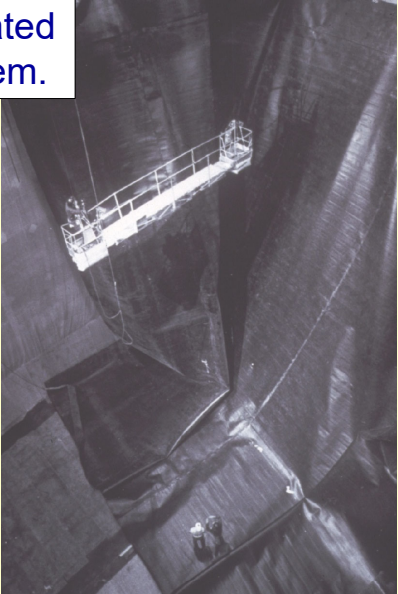
The reservoir had **right-angle corners**.

This is another example of structural design done **without taking into account** the requirements of geomembrane installation and performance.

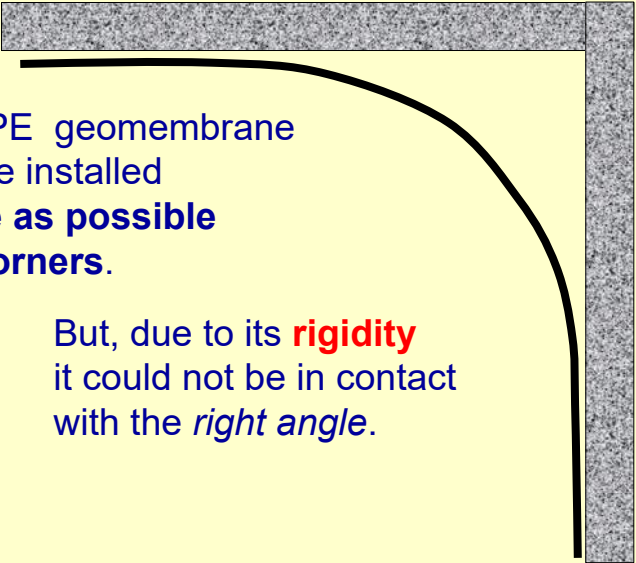
**PLAN VIEW**

The HDPE geomembrane was to be installed **as close as possible to the corners.**

But, due to its **rigidity** it could not be in contact with the *right angle*.

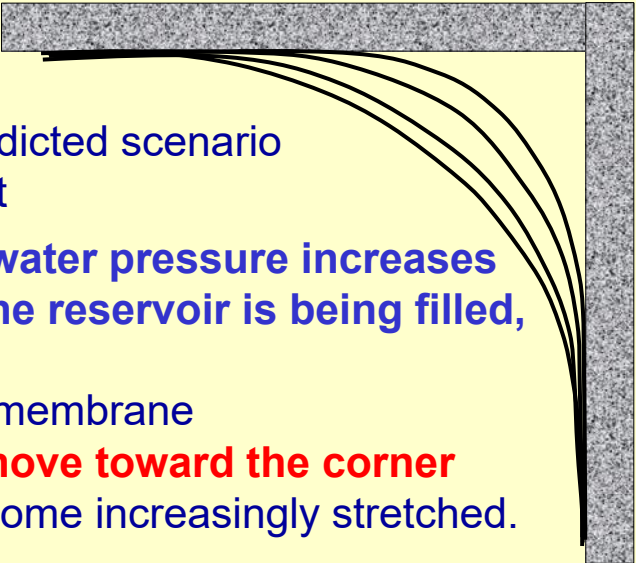
The predicted scenario was that **as the water pressure increases when the reservoir is being filled,** the geomembrane would **move toward the corner** and become increasingly stretched.

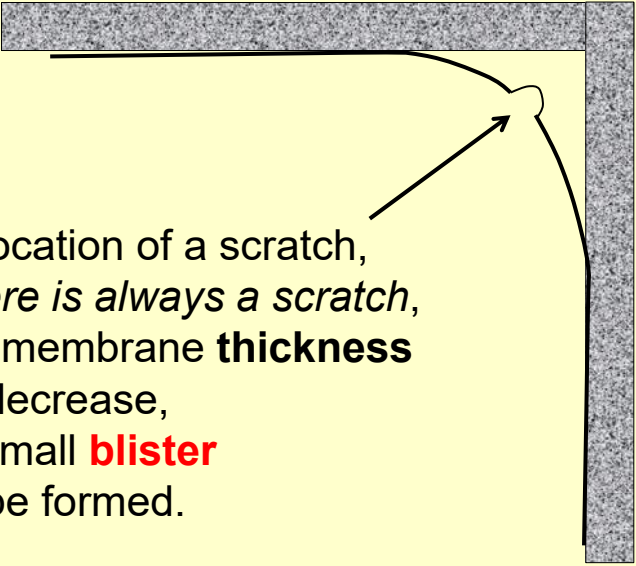
Finally,  
at the location of a scratch,  
*and there is always a scratch,*  
the geomembrane **thickness**  
would decrease,  
and a small **blister**  
would be formed.

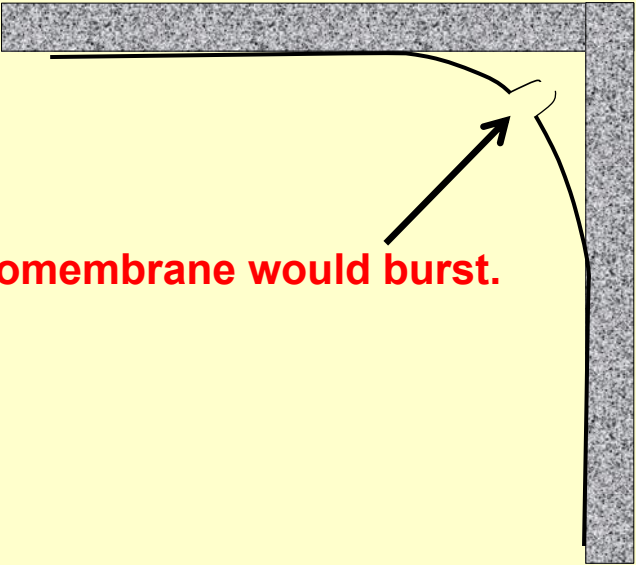
And  
**the geomembrane would burst.**

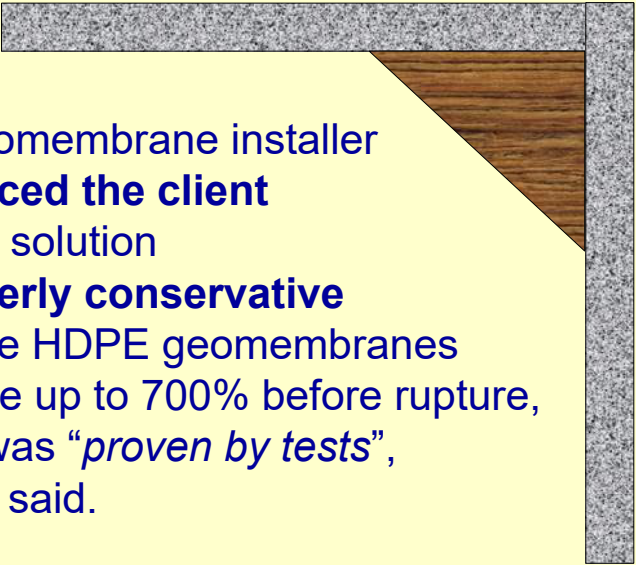
The diagram shows a cross-section of a corner where a horizontal concrete slab meets a vertical concrete wall. A brown geomembrane is installed over the concrete. The corner is chamfered, meaning the sharp 90-degree angle is replaced by a 45-degree slope. An arrow points from the text to this chamfered corner.

The geomembrane installer **convinced the client** that my solution was **overly conservative** because HDPE geomembranes elongate up to 700% before rupture, which was “*proven by tests*”, as they said.

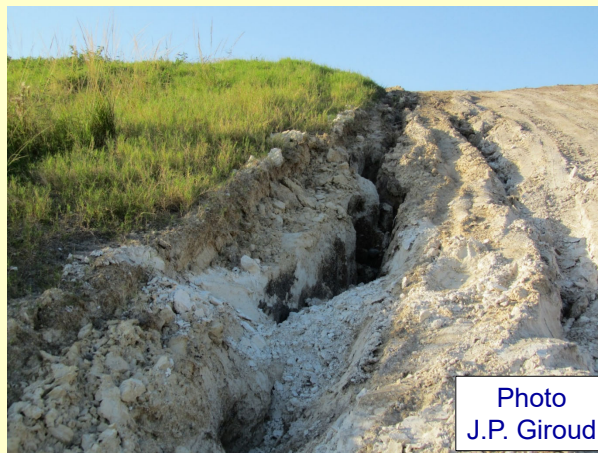
The cavity developed because  
the soil was **highly soluble**  
in water, especially salt water.

The  
**high solubility**  
and **erodability**  
of the soil  
was evidenced  
by deep gullies  
seen at the site.

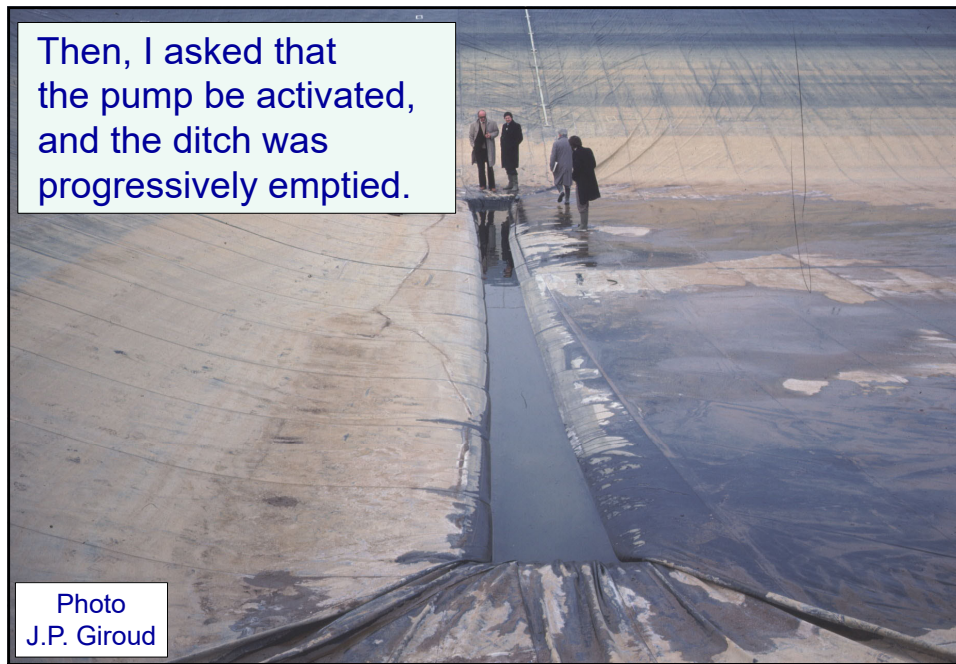
Then, I asked that the pump be activated, and the ditch was progressively emptied.
