# Norton Branch Vegetated Reinforced Soil Slope Revisited After 25 years

A section of Norton branch tributary, located in Sevierville Tennessee, was relocated to maximize space for a shopping center in 1994. To maintain the resulting steep and high banks of the newly relocated stream system and enhance aquatic and wildlife habitat, a vegetated reinforced soil slope system (VRSS) was constructed to contain the flow. This case history explores the use of soil bioengineering to meet the challenges associated with an environmentally sensitive stream diversion project and examines the performance over the course of 25 years. Figures 1 and 2 show during and after completion of construction.

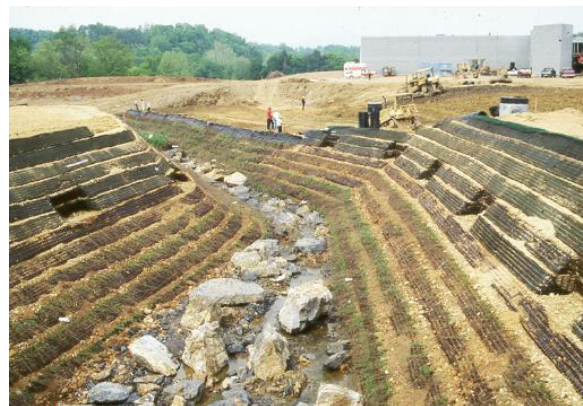
**Figure 2 – Immediately After Construction**

It is important to note that bare-root, nursery-stock plants were used in the soil bioengineering VRSS construction. To restore some of the lost riparian and aquatic habitat, the vegetation was installed in the lower bank wraps. The varieties of plants used included Bankers willow; Salix X cotteti and Streamco willow, and Salix purpurea, which are hybrids, developed by the USDA/NRCS.

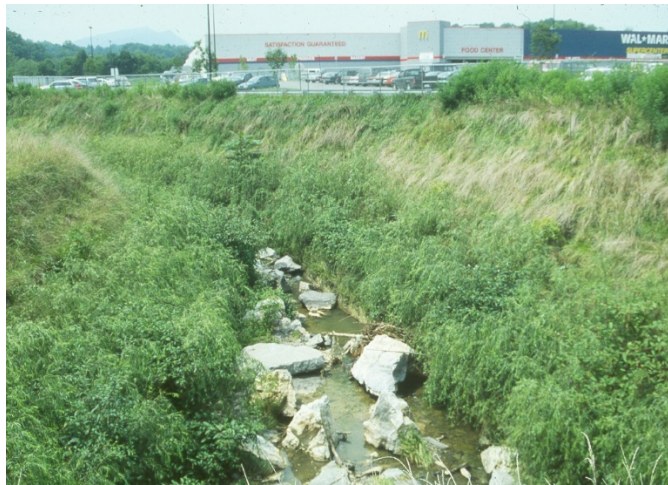
**Figure 3 – Third Growing Season**

As shown in Figures 3 and 4 the reconstructed channel is completely stable. Survival and growth of the plantings has been excellent with growth overhanging approximately two-thirds of the streambed.
